## SEI RESIDENTIAL REPORT

4219 New Hope Church Rd SE  
Acworth, GA 30102

08/31/2026

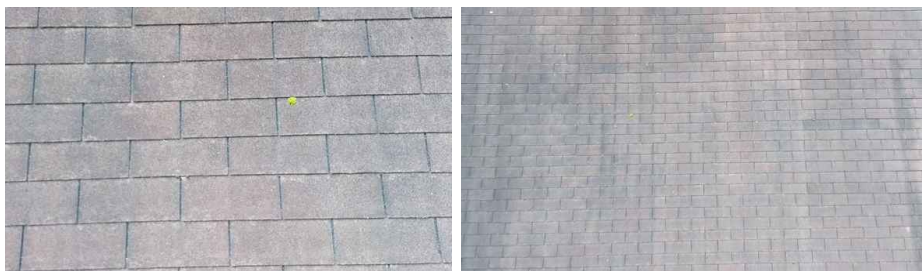
3-tab asphalt shingles are a traditional and economical roofing material consisting of rectangular shingle tabs with a uniform, flat appearance. These shingles are manufactured with a single layer of material and typically have a lifespan of 15-20 years, depending on climate conditions, installation quality, and maintenance.

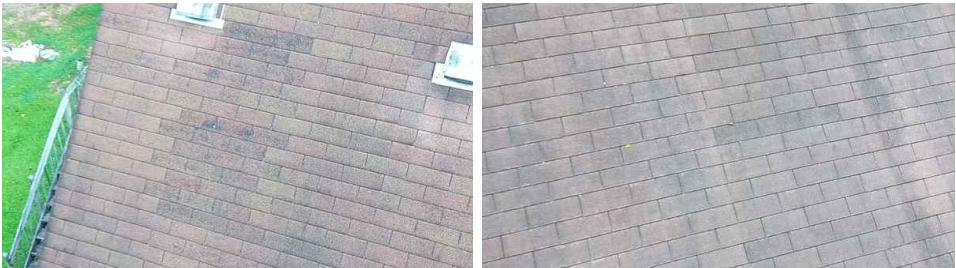
2.1.3 Coverings

**SHINGLES - PREVIOUS REPAIR**

Recommendation

Contact a qualified professional.

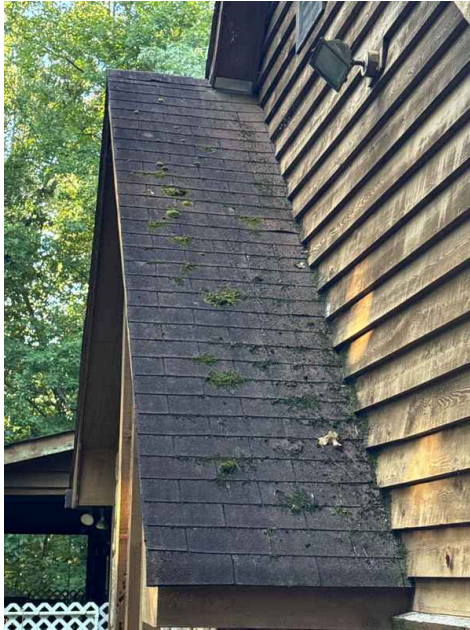
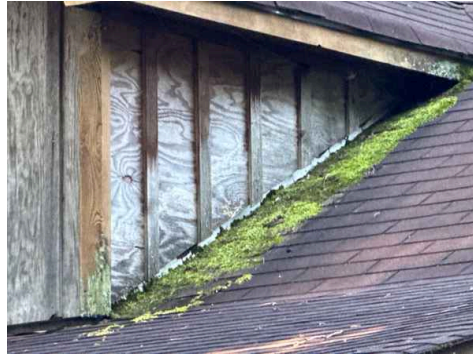
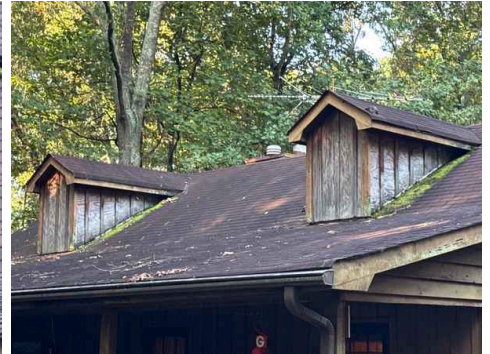
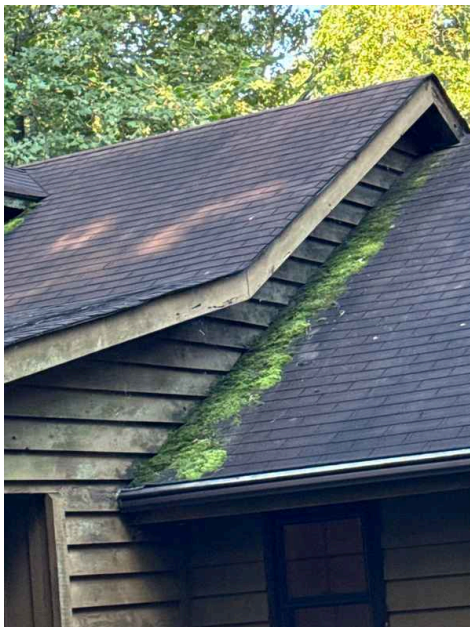
## 2.1.4 Coverings

**SHINGLES - ORGANICS / MOSS**

Recommendation

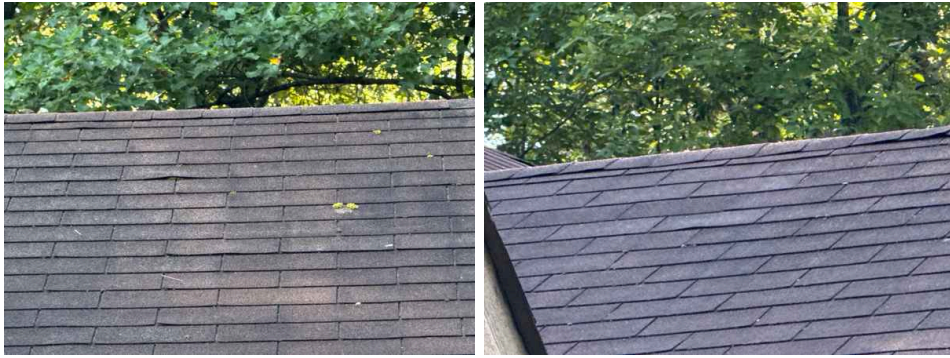
Observe pop nails at roof shingles at time of inspection.

Recommend further evaluation/repair by qualified, licensed roofing contractor.

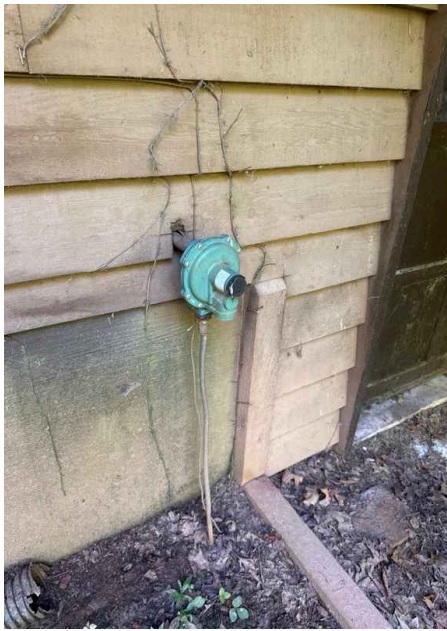
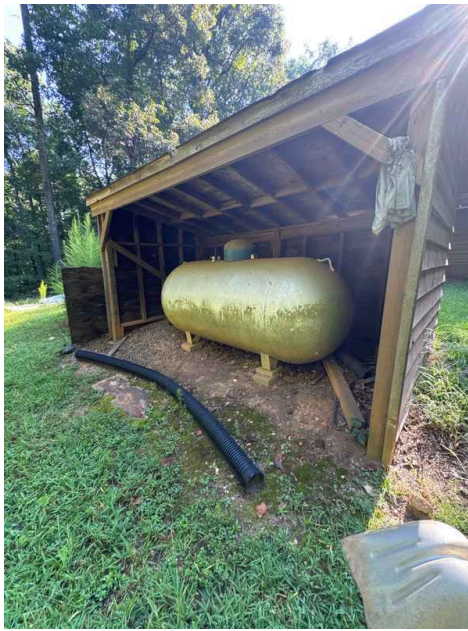
## Fuel Storage & Distribution Systems: Main Gas Shut-off Location

Exterior Back

At Tank

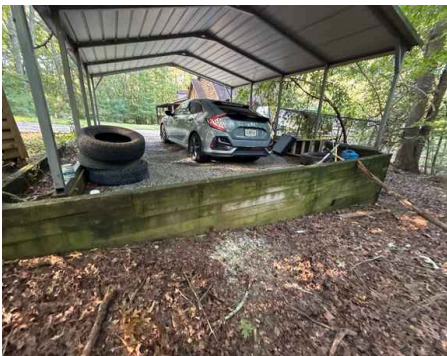
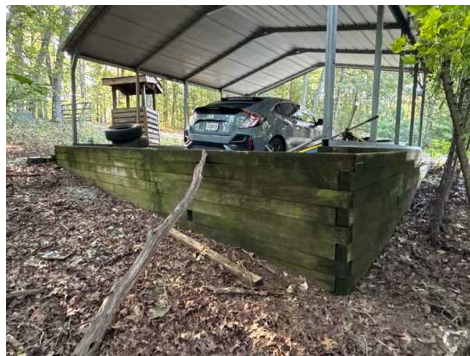
## Retaining Walls: Retaining Wall

Exterior Front Right

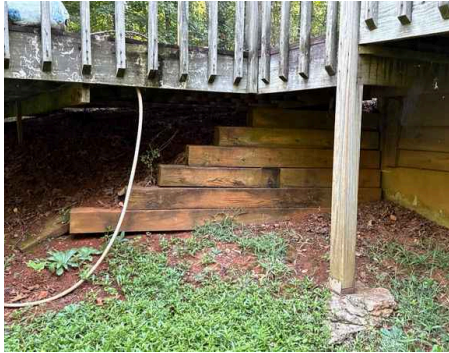
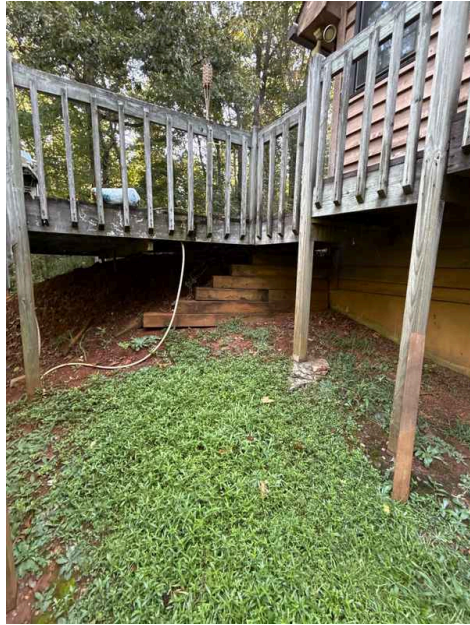
## Retaining Walls: Retaining Wall 2

Exterior Back

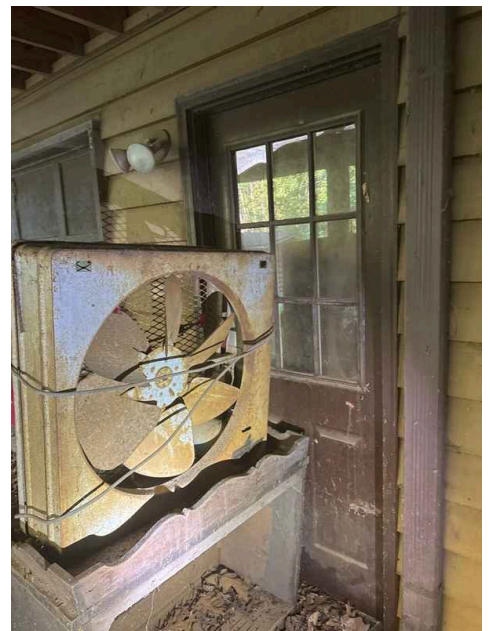
EXTERIOR BACK

Doors inaccessible at time of inspection. Unable to fully operate at time of inspection.

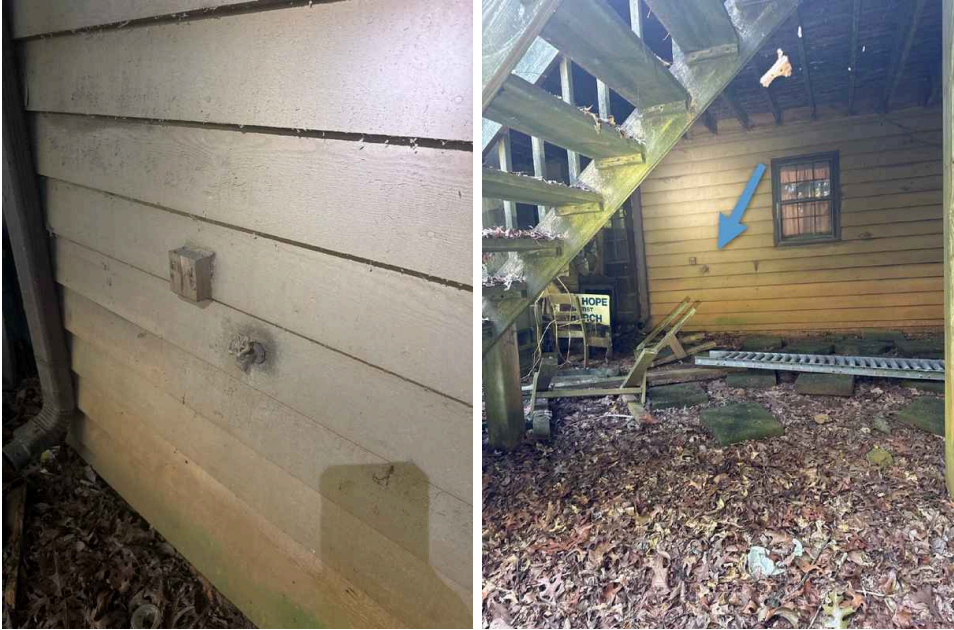
3.3.1 Siding, Flashing & Trim

**SIDING - GROUND CLEARANCE**

Inadequate clearance between siding and ground. Recommend a minimum ground clearance between bottom of siding and ground of 4". Siding in contact with the ground or soil is a serious concern because that condition can provide direct access for wood destroying insects and significant wood rot/moisture.

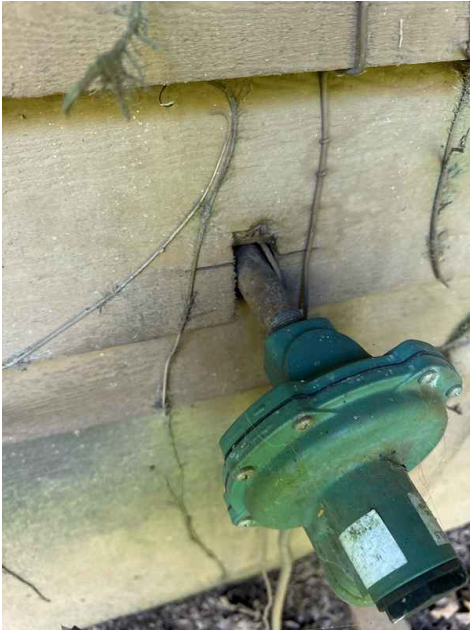
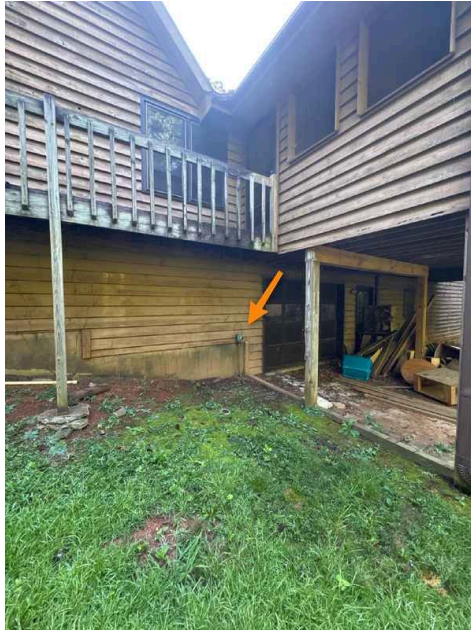
### 3.3.4 Siding, Flashing & Trim

#### **SIDING - PREVIOUS REPAIRS**

Observed siding previously repaired in multiple instances at time of inspection. Existing conditions suggest previous damage and recent repair work at exterior of structure.

Recommend additional information regarding previous scope of repairs.

Recommend further consultation with a qualified, licensed contractor to diagnose and suggest additional repairs as needed for proper function.

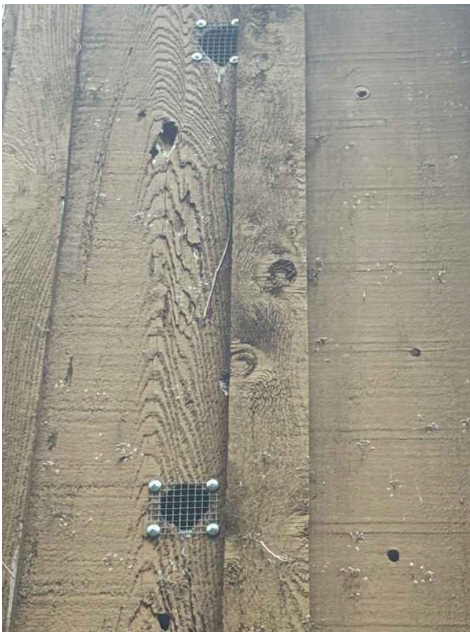
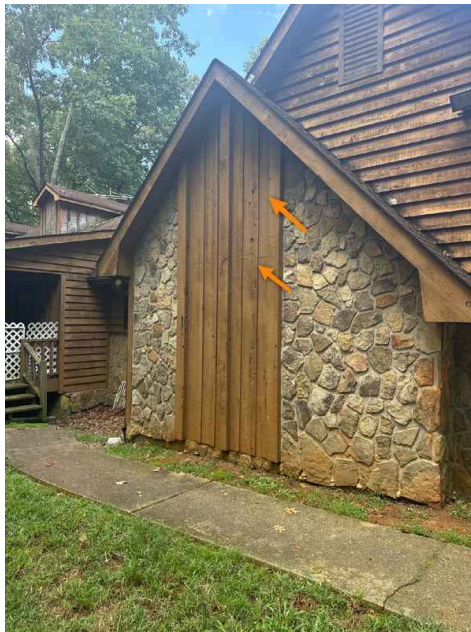
## 3.3.5 Siding, Flashing &amp; Trim

**SIDING - PEST, DAMAGE**

Observed pest damage to exterior siding at time of inspection.

Recommend repair or replace as needed by a qualified licensed contractor.

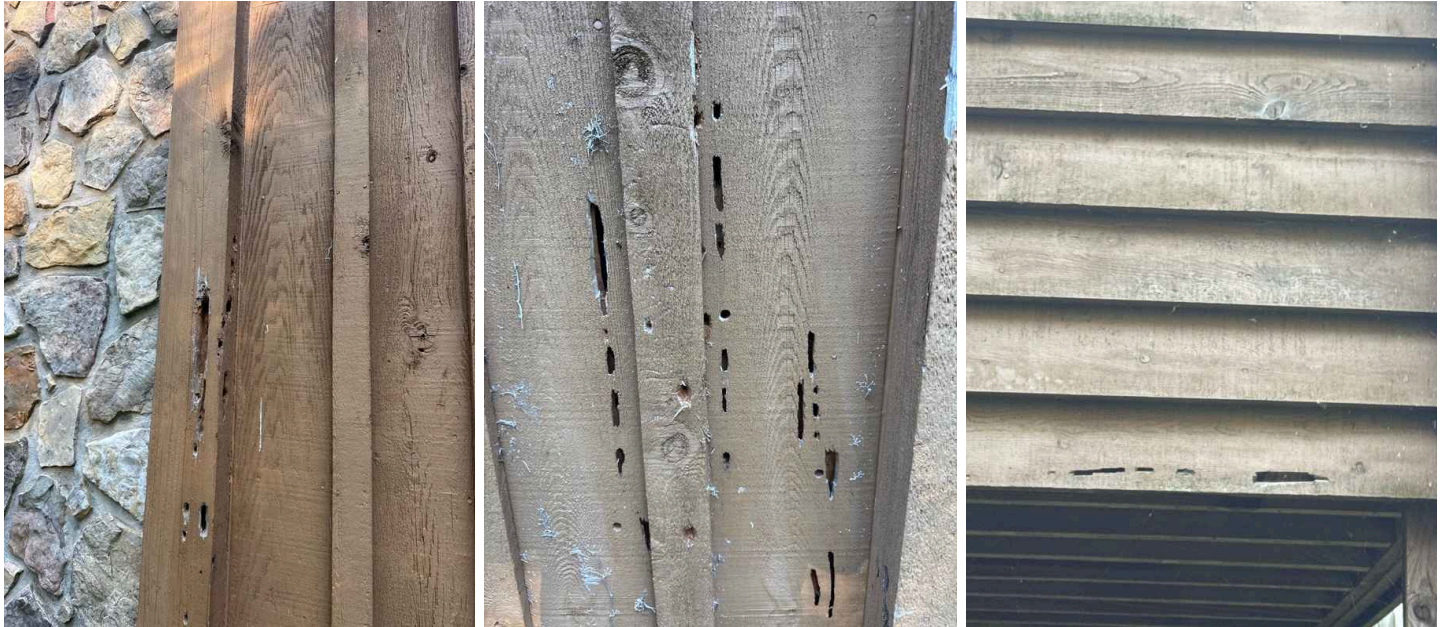
## 3.3.6 Siding, Flashing &amp; Trim

**SIDING - CAULKED JOINTS DETERIORATED**

Observed separated or deteriorated caulking between joints at exterior siding at time of inspection.

Recommend minor corner and repair as needed.

Recommend caulking and sealing siding joints throughout exterior by a qualified, licensed professional.

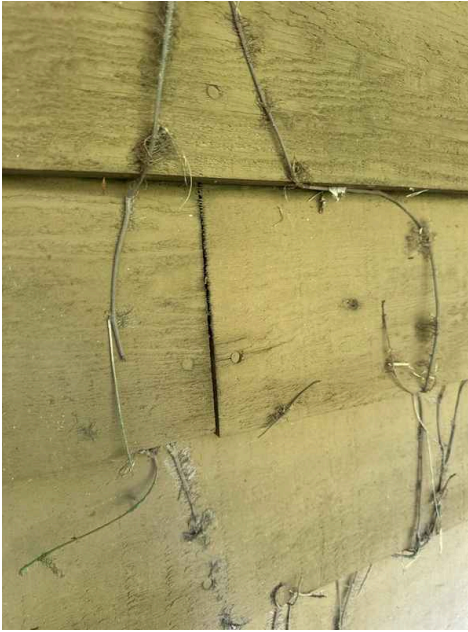
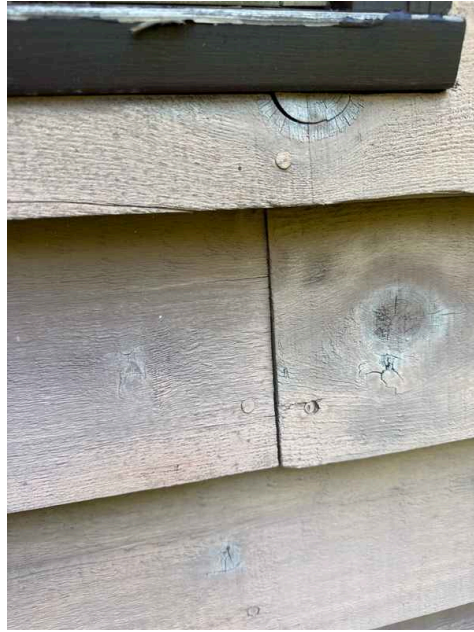
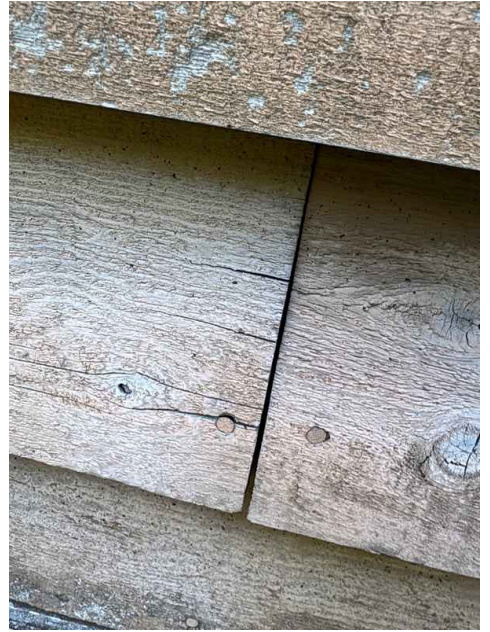
### 3.3.7 Siding, Flashing & Trim

#### **TRIM - ROT**

Observed trim at exterior soft and rotted at time of inspection.

Recommend repair or replace as needed by a qualified, licensed professional.

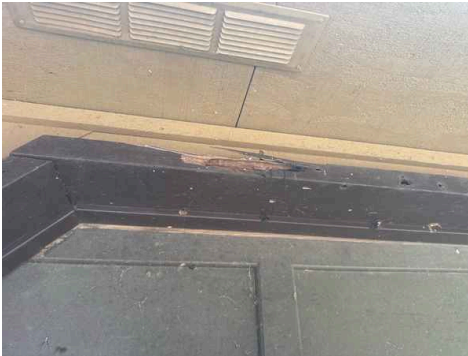
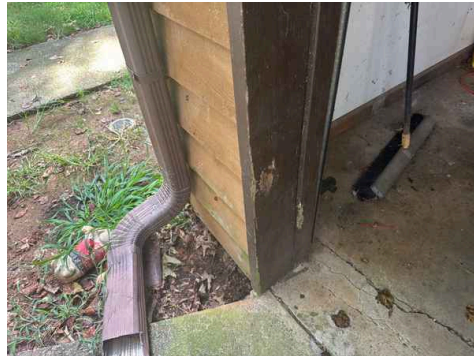
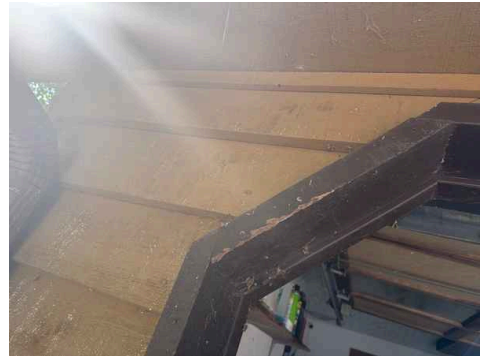
### 3.4.1 Eaves, Soffits & Fascia

#### **SOFFIT / FASCIA - WATER DAMAGE / ROT**

Observed conditions of fascia/soffit water intrusion and/or damage at time of inspection.

Recommend repair or replace as needed by a qualified, licensed professional.

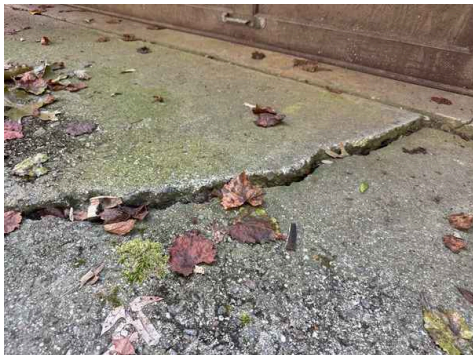
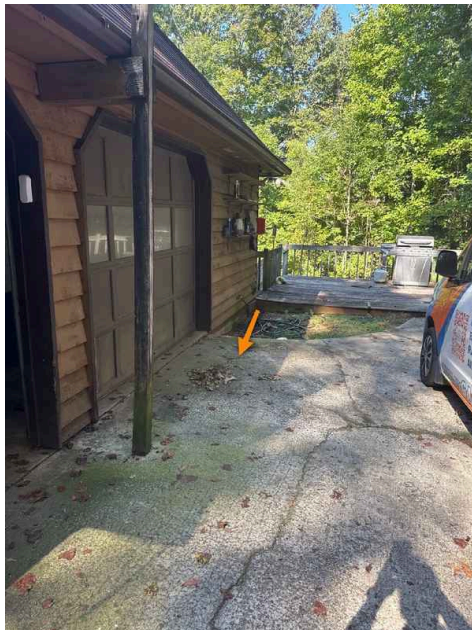
## 3.8.2 Walkways, Patios &amp; Driveways

**WALKWAY - CRACKING, DAMAGE**

Significant cracks/damage observed at walkway at time of inspection. Concrete cracking atypical.

Recommend concrete contractor evaluate and correct to prevent trip hazard & preserve appearance.

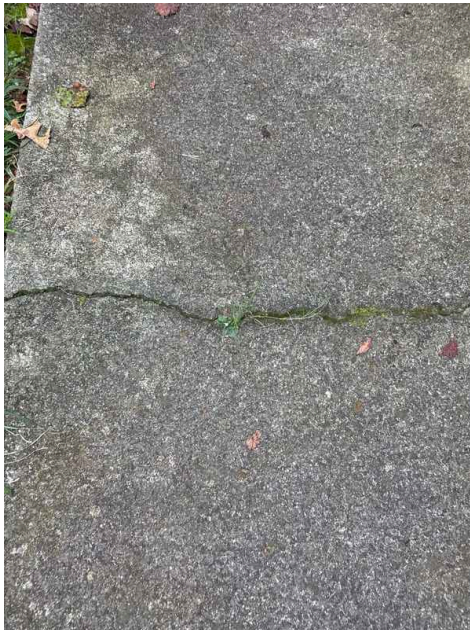
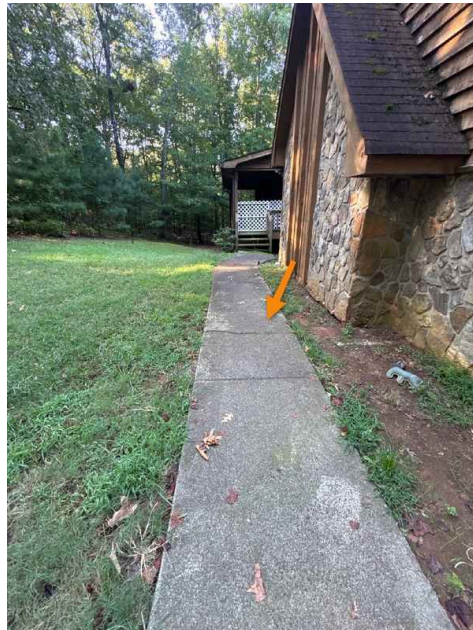
## 3.8.3 Walkways, Patios &amp; Driveways

**WALKWAY - UNEVEN / TRIP HAZARD**

Observed Uneven and/or displaced areas of walkway at exterior of structure at time of inspection.

Recommend repair or replace damaged areas of walkway as needed by a qualified, licensed professional.

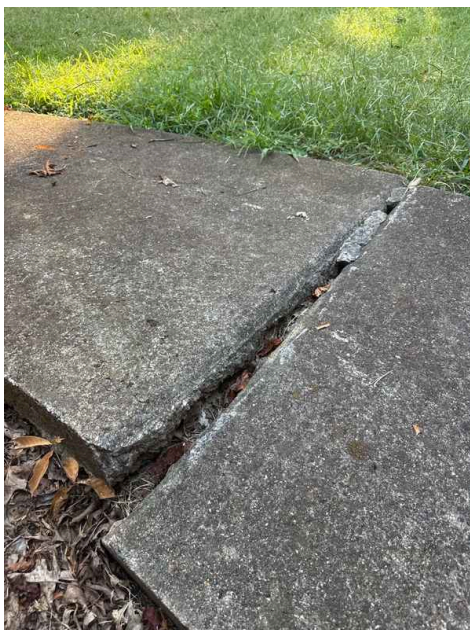
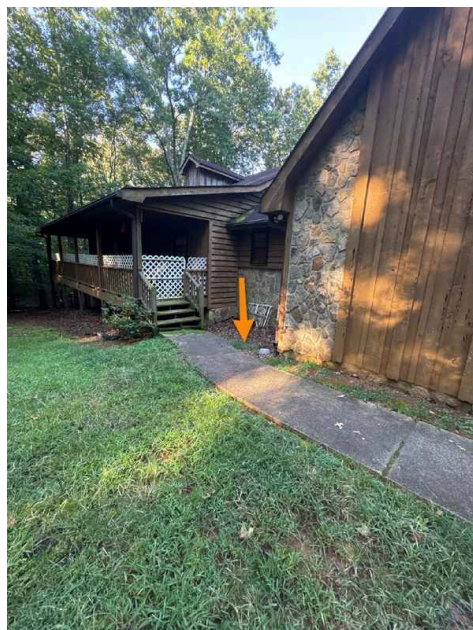
## 3.8.4 Walkways, Patios &amp; Driveways

**DRIVEWAY - WASHOUT**

Observed washout and/or settlement at driveway at time of inspection.

Recommend repair or replace as needed by a qualified, licensed professional.

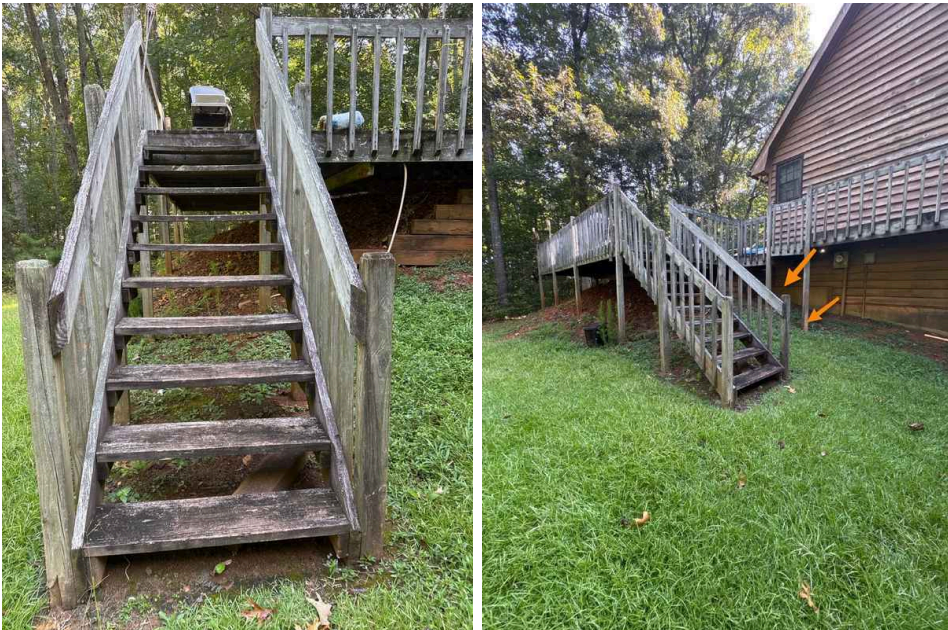
### 3.9.3 Decks, Balconies, Porches & Steps

#### **DECK / PORCH - LOOSE HANDRAILS**

One of more areas of the deck/porch handrail support appears unstable. This could cause a safety hazard. Recommend qualified, licensed deck contractor to further evaluate and repair as needed.

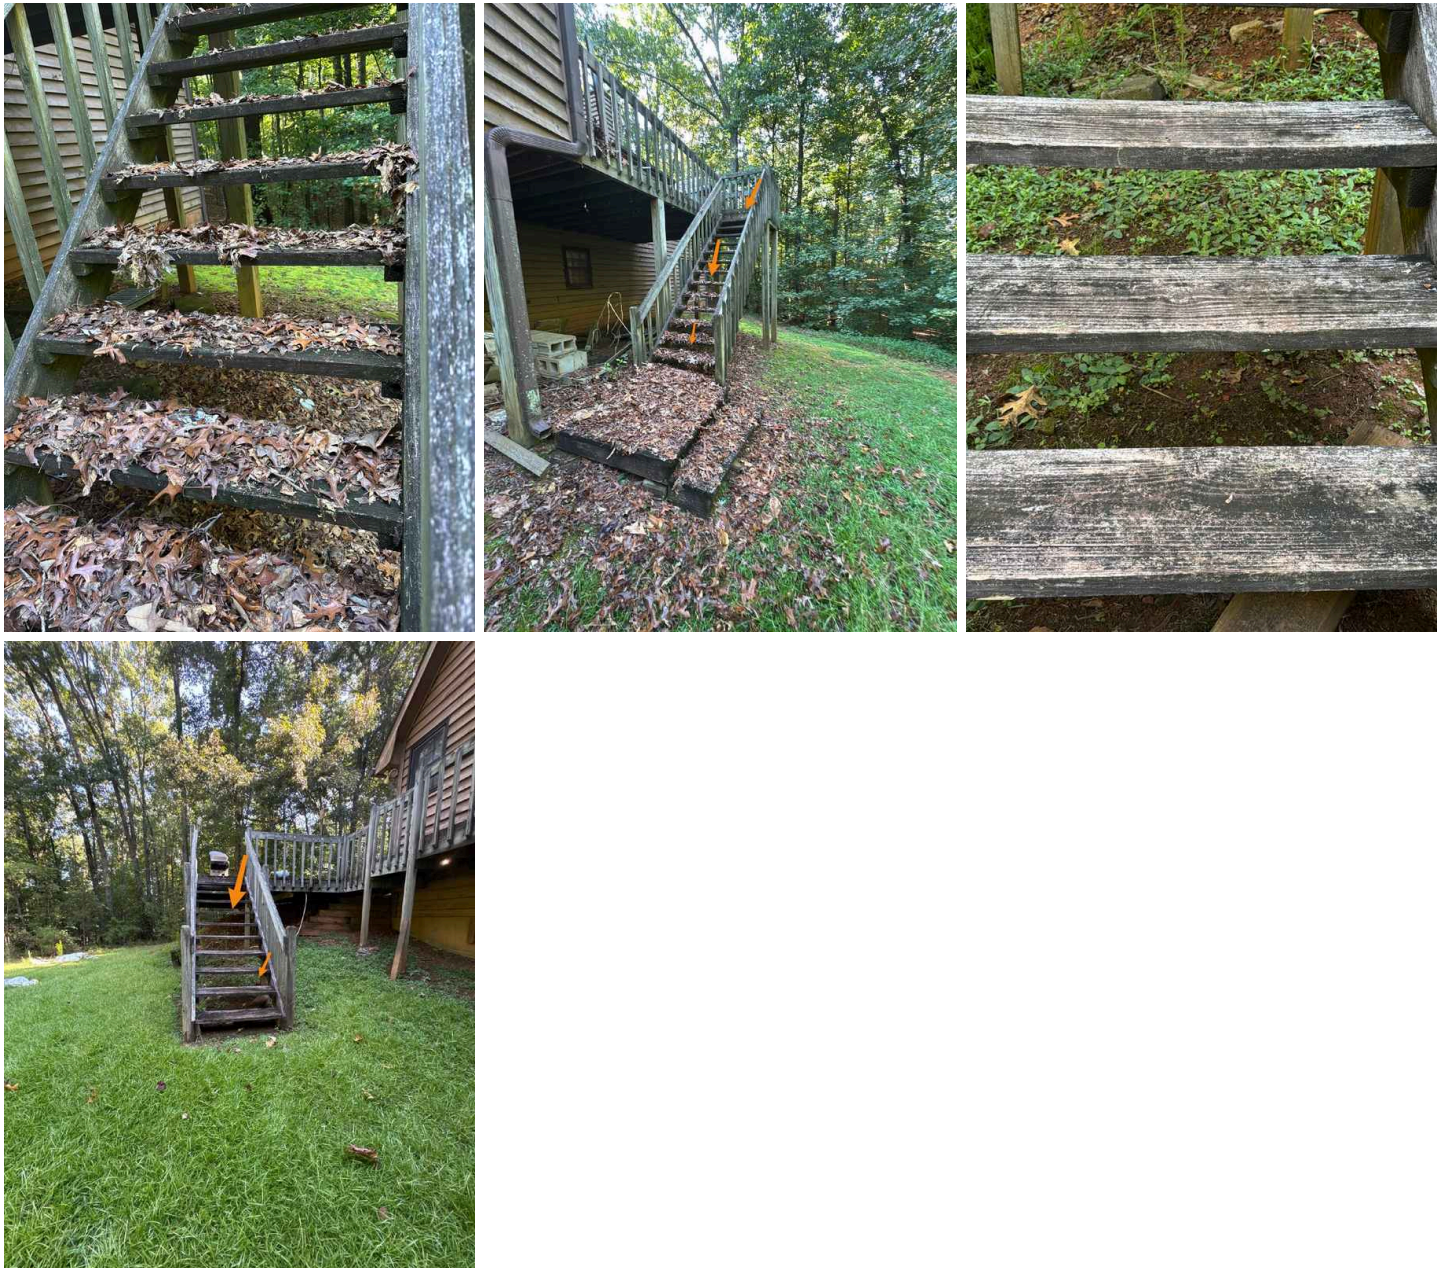
### 3.9.4 Decks, Balconies, Porches & Steps

#### **STAIRS - DETERIORATED**

One or more sections of the exterior stairs are deteriorated.

Recommend further consultation with a qualified, licensed contractor to diagnose and suggest repairs as needed for proper function.

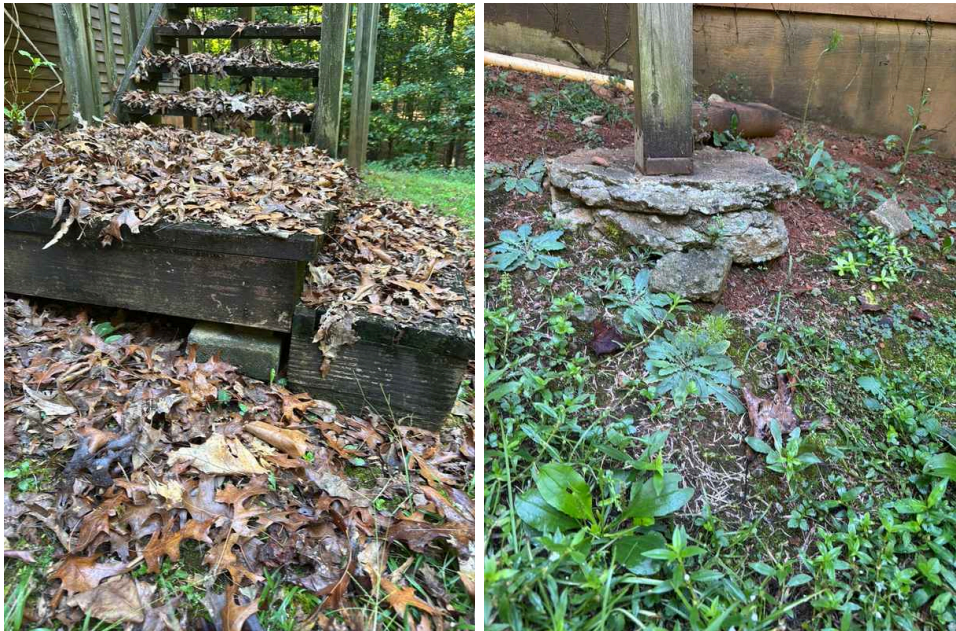
3.9.6 Decks, Balconies, Porches & Steps

HANDRAIL - ROT

Observed multiple conditions of rot at handrail at time of inspection  
Recommend repair or replace rotted handrail material as needed by a qualified, licensed professional.

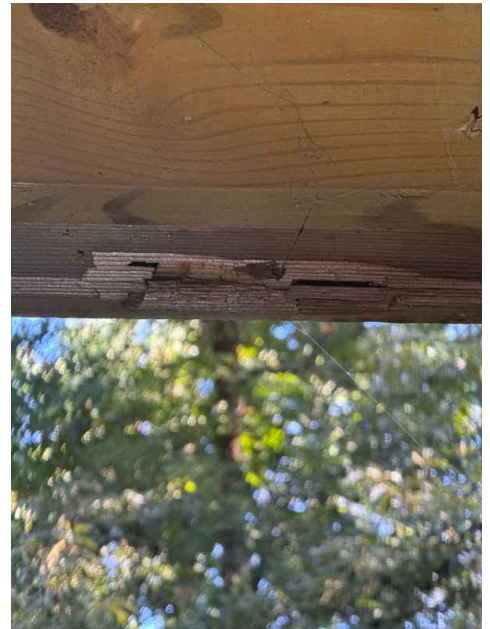
### 3.9.8 Decks, Balconies, Porches & Steps

#### **UNEVEN / CRACKED BOARDS**

Observed uneven and or cracked boards at time of Inspection. Observed multiple knots on top sides of boards raised and missing.

Recommend further evaluation and repair by a qualified and licensed professional.

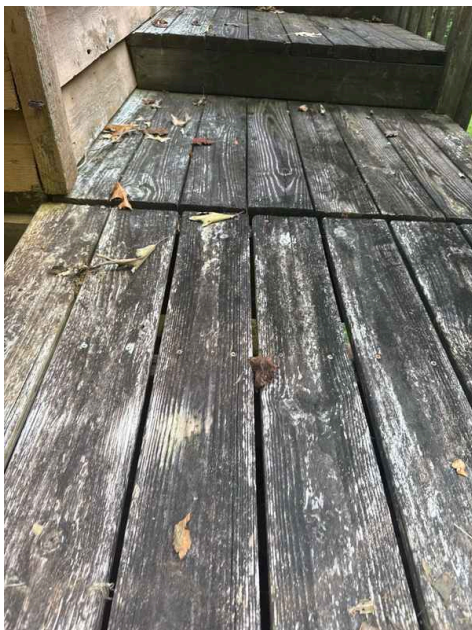
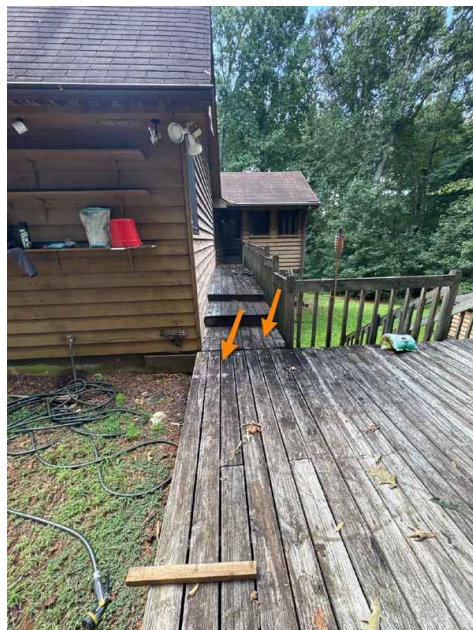
### 3.9.9 Decks, Balconies, Porches & Steps

#### **BALUSTER - LOOSE**

The baluster / pickets observed loose at time of inspection.

Recommend a qualified handyman or original installer repair or replace as needed.

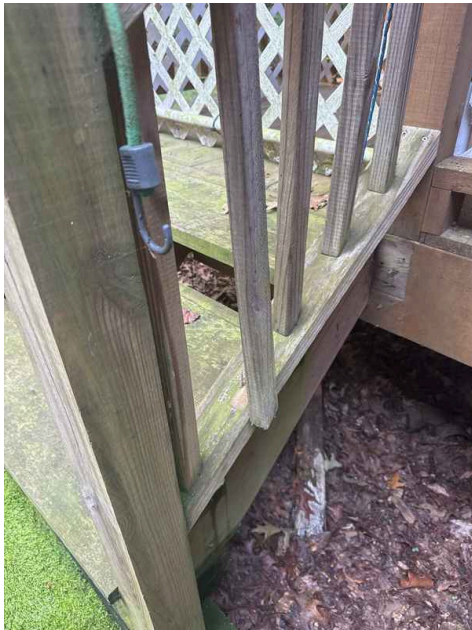
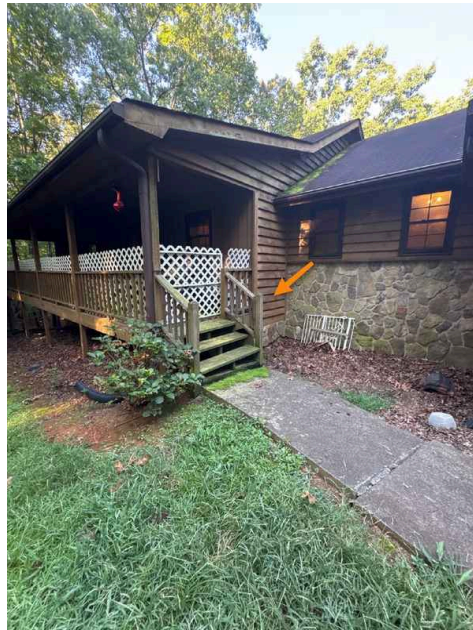
### 3.9.10 Decks, Balconies, Porches & Steps

#### **LANDING - MISSING/IMPROPER**

Observed improperly installed landing at deck steps/door at time of inspection.

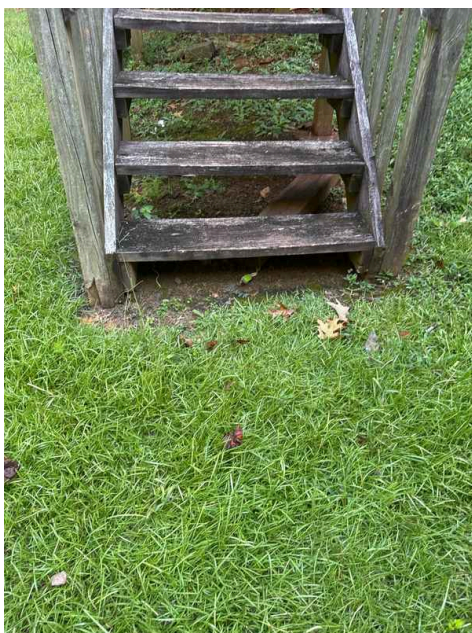
## 3.9.11 Decks, Balconies, Porches &amp; Steps

**FRAMING - SEPARATION**

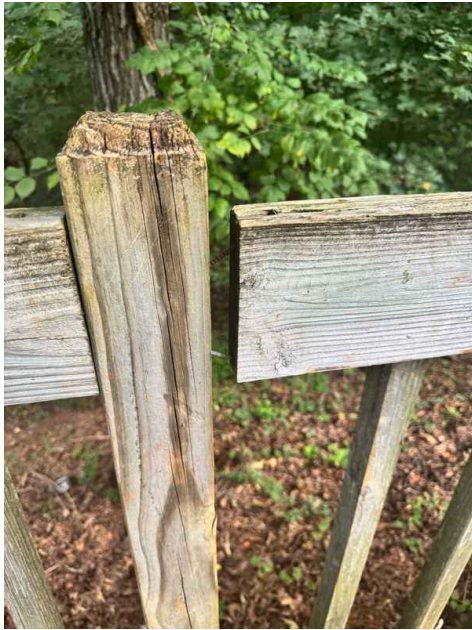
## 3.9.12 Decks, Balconies, Porches &amp; Steps

**DECK - WOOD TO GROUND**

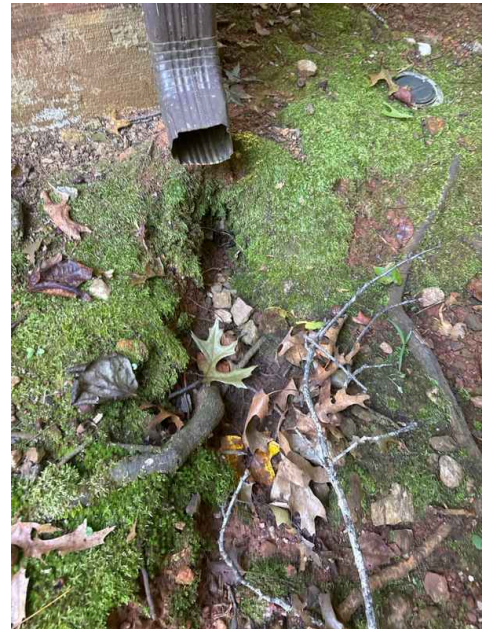
Observed significant silt and soil erosion at exterior of structure.

Recommend further consultation with a qualified, licensed landscape contractor to diagnose and suggest repairs as needed for proper function and drainage.

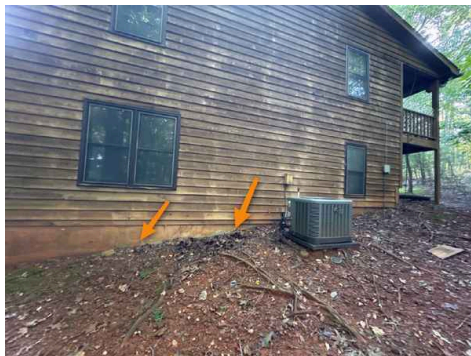
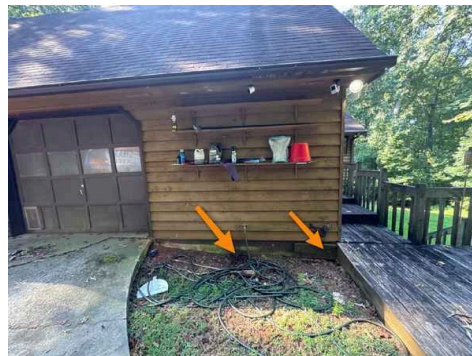
### 3.10.2 Vegetation, Grading, Drainage & Retaining Walls

Grading is sloping towards the home or flat in some areas. This could lead to water intrusion and foundation issues. Recommend qualified landscaper or foundation contractor regrade so water flows away from home.

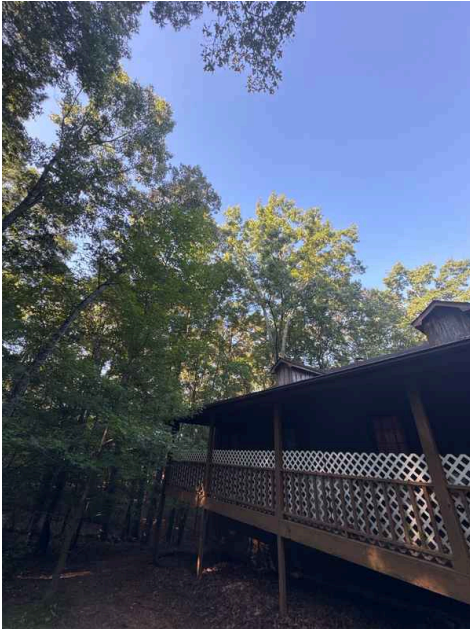
### 3.10.3 Vegetation, Grading, Drainage & Retaining Walls

Trees observed overhanging the roof. This causes damage to the roof from falling debris and prevents proper drainage if not regularly maintained.

Recommend a qualified tree service trim to allow for proper drainage.

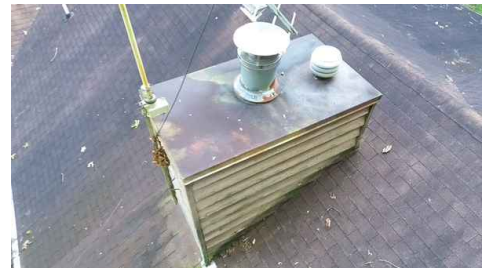
### 3.11.1 Chimney

#### **CHIMNEY CAP - METAL / RUST**

The metal chimney cap shows evidence of rust.  
Recommend repair or replace as needed by a qualified, licensed professional.

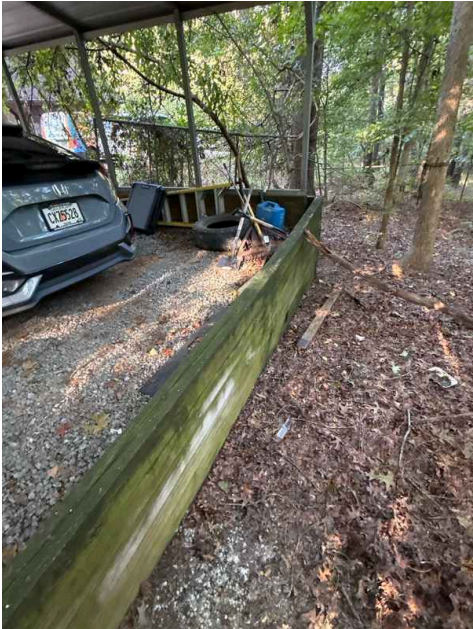
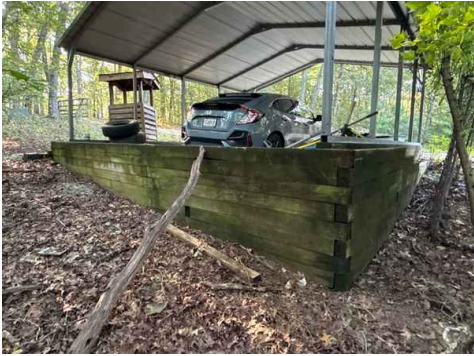
### 3.12.1 Retaining Walls

#### **RETAINING WALL - LEANING**

Retaining wall showing signs of failure at time of inspection. Retaining wall leaning/out of plumb.  
Recommend repair or replace as needed by a qualified, licensed professional.

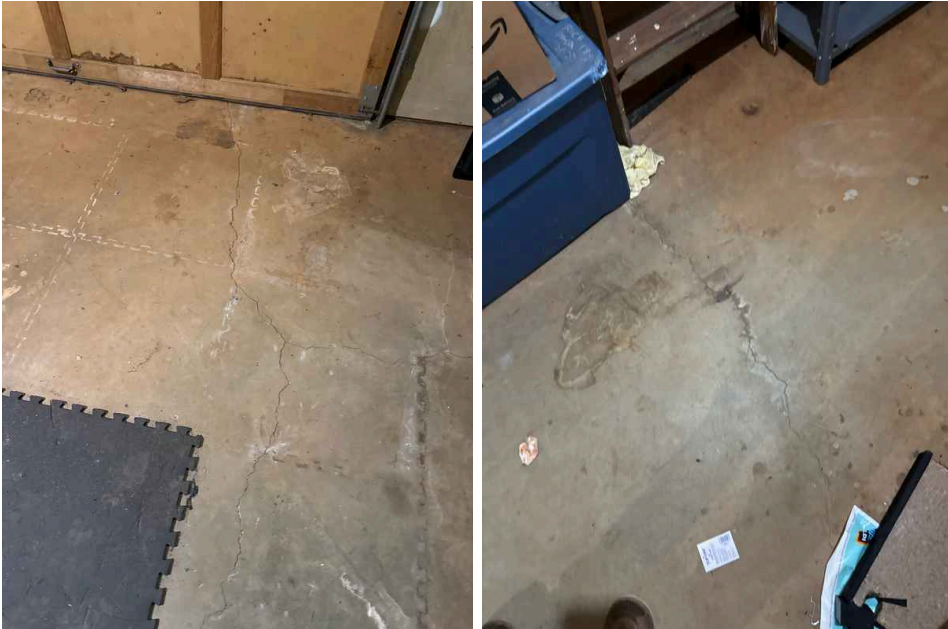
#### 4.3.1 Floor Structure

### CONCRETE SLAB - SETTLEMENT

Concrete slab was found to have cracked/separated at the floor structure.

This can be caused by common settlement of the home and/or soil movement.

Recommend further consultation with a qualified, licensed structural contractor to diagnose and suggest repairs as needed for proper function.

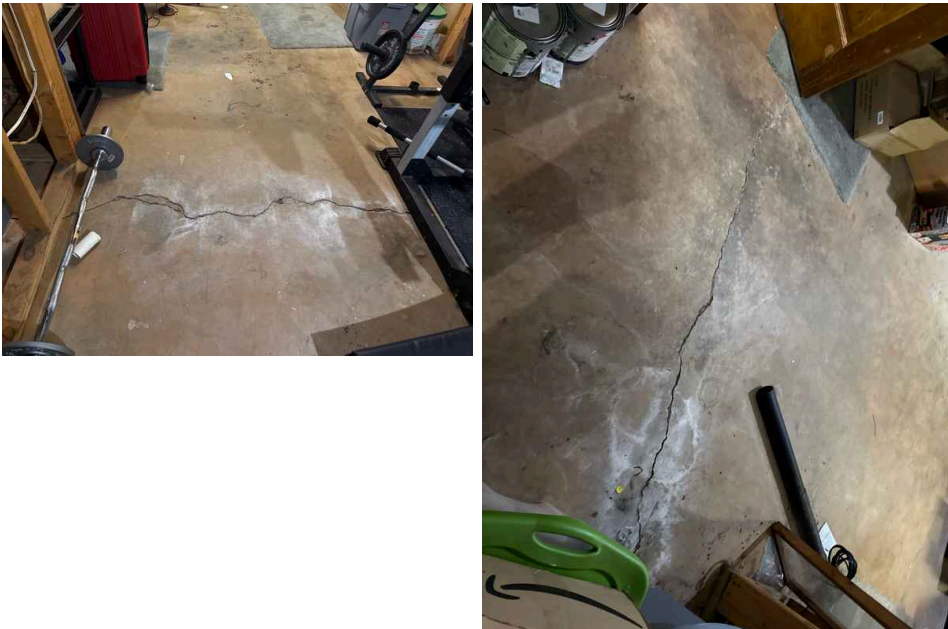
#### 4.3.2 Floor Structure

### CONCRETE SLAB - SIGNIFICANT

Concrete slab was found to be shifting/cracking at the floor structure. This can be caused by common settlement and/or soil movement.

Recommend further consultation with a qualified, licensed structural contractor to diagnose and suggest repairs as needed for proper function.

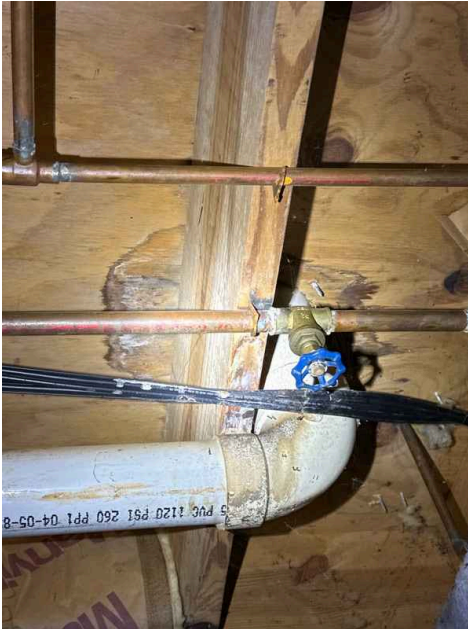
Ceiling structure showed signs of water intrusion, which could lead to more serious structural damage.

Observed conditions of previous moisture damage and signs of potential microbial growth where moisture affected materials observed.

Recommend further consultation with a qualified, licensed contractor to diagnose and suggest repairs as needed for proper function.

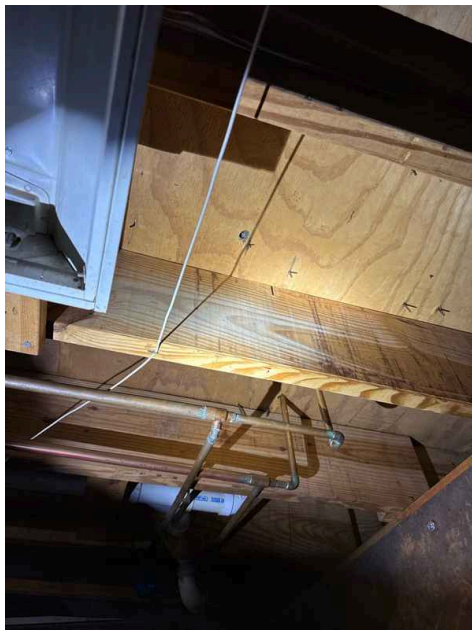
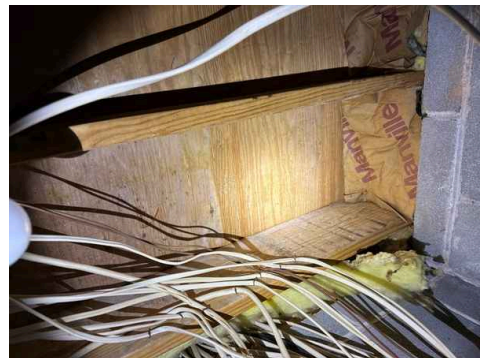
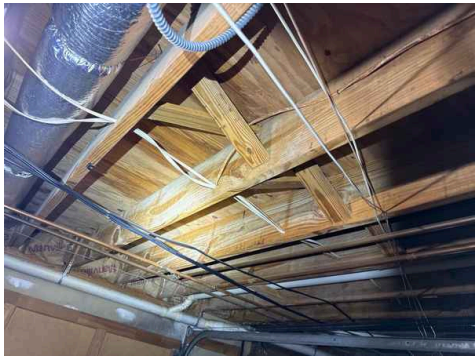
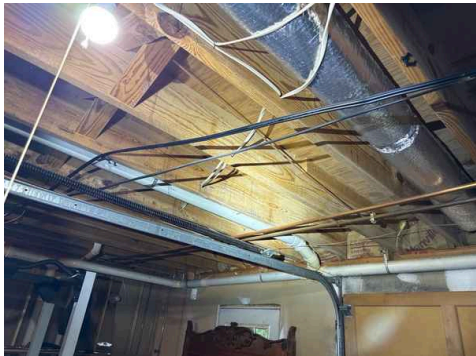
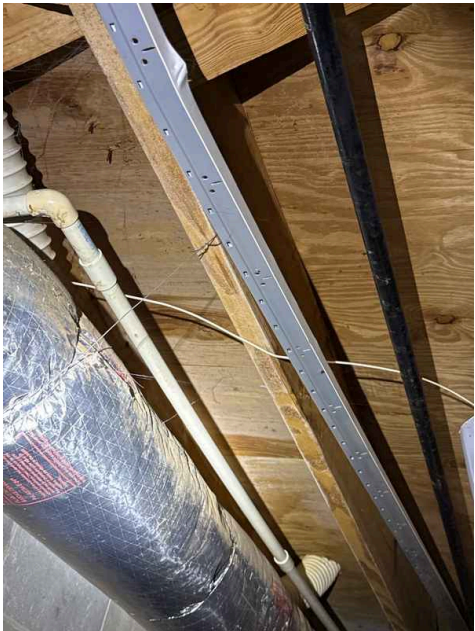
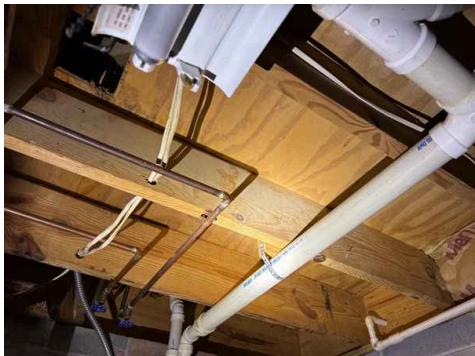
#### 4.5.2 Ceiling Structure

### POTENTIAL MICROBIAL GROWTH

Observed multiple areas of potentially active microbial growth throughout lower level.

Recommend remediation of moisture source, remove and replace potentially affected materials throughout area.

Recommend treatments to be thorough and complete.

Recommend all work be completed by a a qualified, licensed remediation professional.

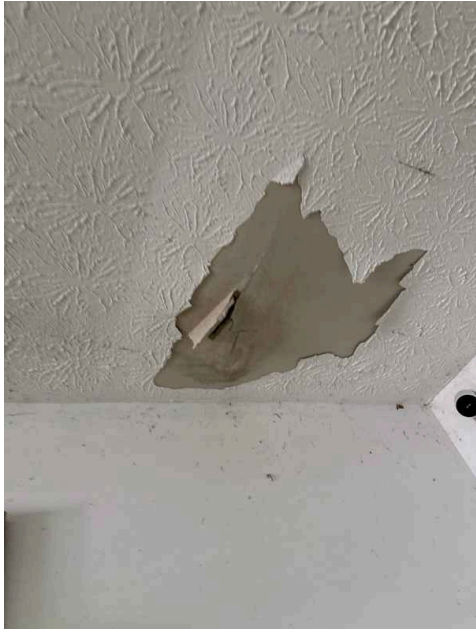
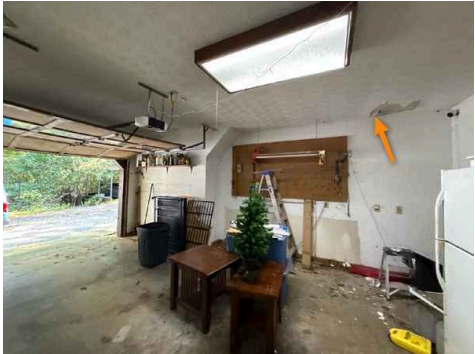
5.2.1 Walls & Firewalls

POTENTIAL MICROBIAL GROWTH

Observed potential microbial growth at wall materials in the garage at time of inspection. Air quality/mold testing recommended as an additional service at time of inspection.

Recommend further consultation with a qualified, licensed contractor to diagnose and suggest repairs as needed for proper function.

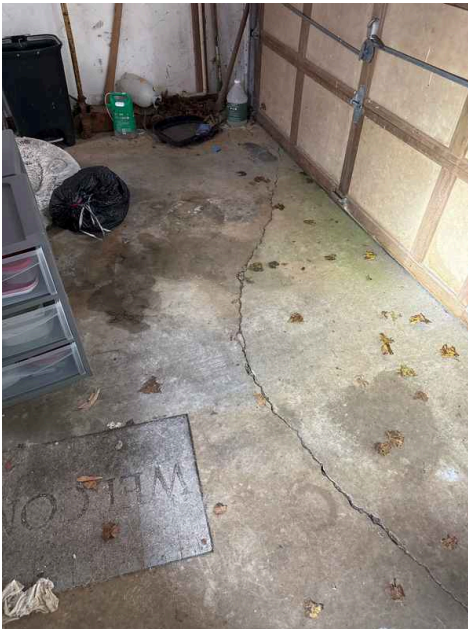
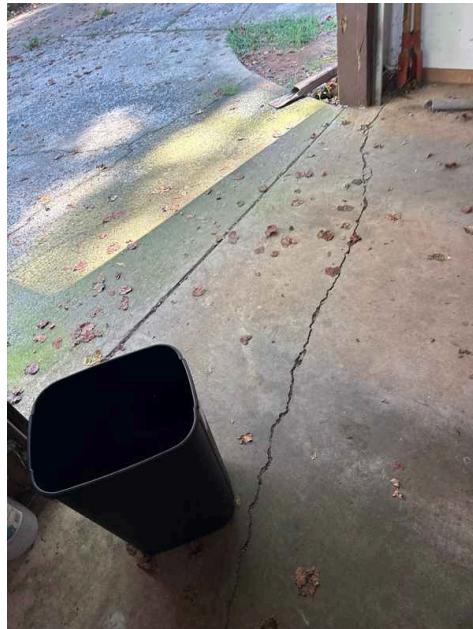
#### 5.4.1 Garage Door

##### **SPRINGS - MISSING**

Observed garage door springs missing at time of inspection

Recommend repair or replace as needed by a qualified, licensed professional.

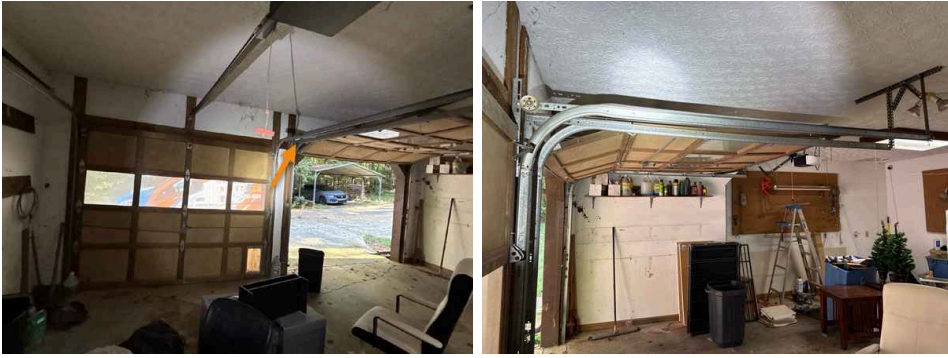
#### 5.5.1 Garage Door Opener

### **GARAGE DOOR - NONFUNCTIONAL**

Unit observed damaged at time of inspection. Unable to operate.

Recommend further consultation with a qualified, licensed contractor to diagnose and suggest repairs as needed for proper function.

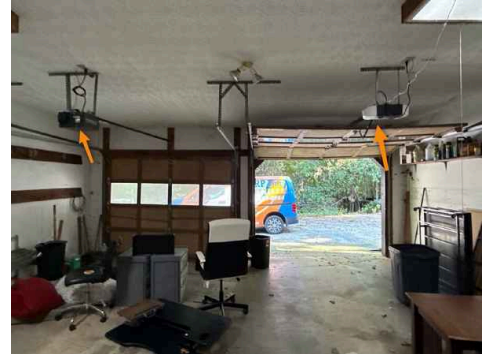
#### 5.6.1 Garage Door- Basement

### **WATER INTRUSION - DAMAGE**

Observed water intrusion (damage) at garage doors at time of inspection.

Recommend repair or replace as needed by a qualified, licensed professional.

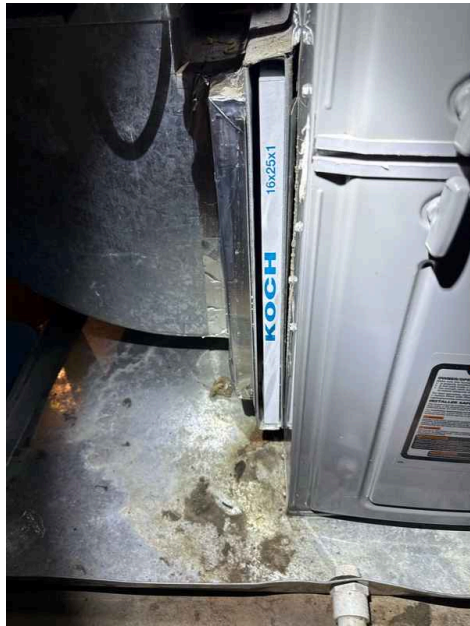
## Filters: Filter In Place

Filter in place at time of inspection. Recommend changing every 30 days as part of regular home maintenance or as directed by the filter manufacturer.
