## SEI RESIDENTIAL REPORT

4219 New Hope Church Rd SE  
Acworth, GA 30102

08/31/2026

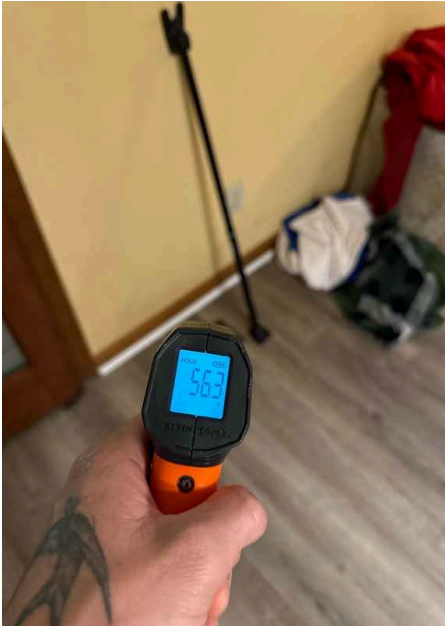
**Cooling Equipment: Temperature Differential**

> 10° difference, Normal Ranges

Air conditioning systems operated using normal thermostatic controls at time of inspection.

Temperatures checked with infrared thermometer at time of inspection. (See Photos)

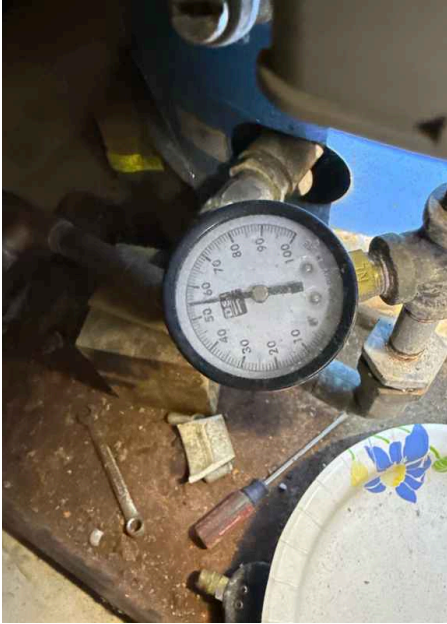
## Main Water Shut-off Device: House Water Pressure - PSI

Record of water pressure at time of inspection. Observed within normal ranges.

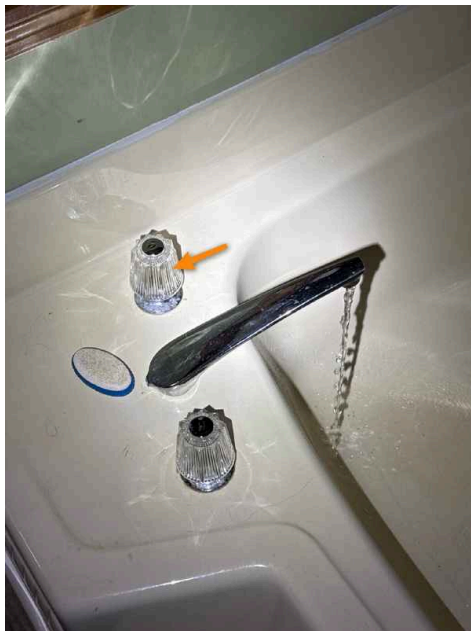
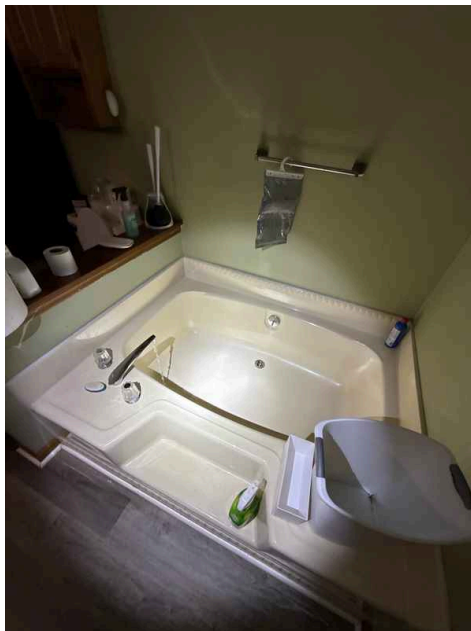
**FIXTURE - DAMAGED**

Recommend repair or replace as needed by a qualified, licensed professional.

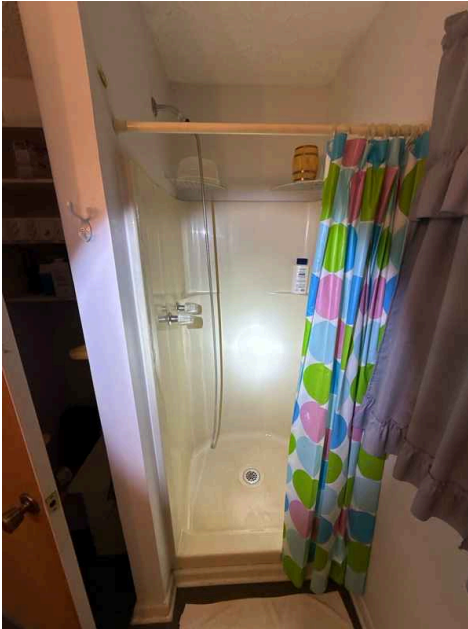
## 9.2.2 Water Supply, Distribution Systems &amp; Fixtures

**FIXTURE - INCOMPLETE**

Recommend repair or replace as needed by a qualified, licensed professional.

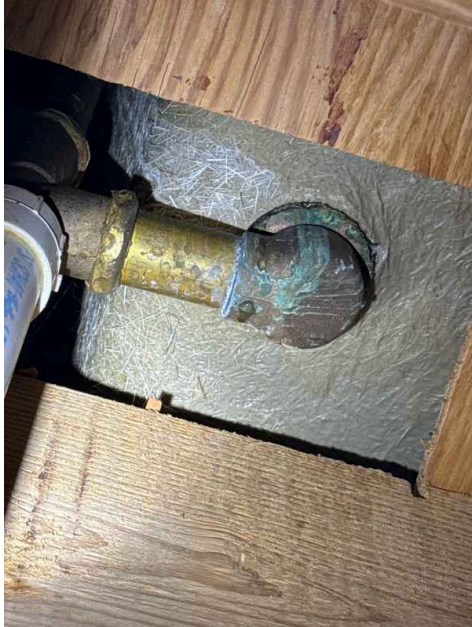
### 9.3.2 Drain, Waste, & Vent Systems

#### **DRAIN LINE - LEAK**

Observed water leak at drain line at time of inspection.

Recommend further consultation with a qualified, licensed contractor to diagnose and suggest repairs as needed for proper function.

Contact a qualified plumbing contractor.

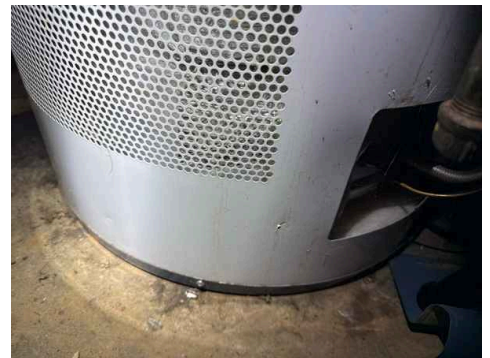
#### 9.5.1 Hot Water Systems, Controls, Flues & Vents

##### **WATER STAINS - LEAKAGE**

Water stains were observed at and/or beneath water heater, indicating a past or present leak. Recommend further evaluation with repair or replacement by a qualified plumber.

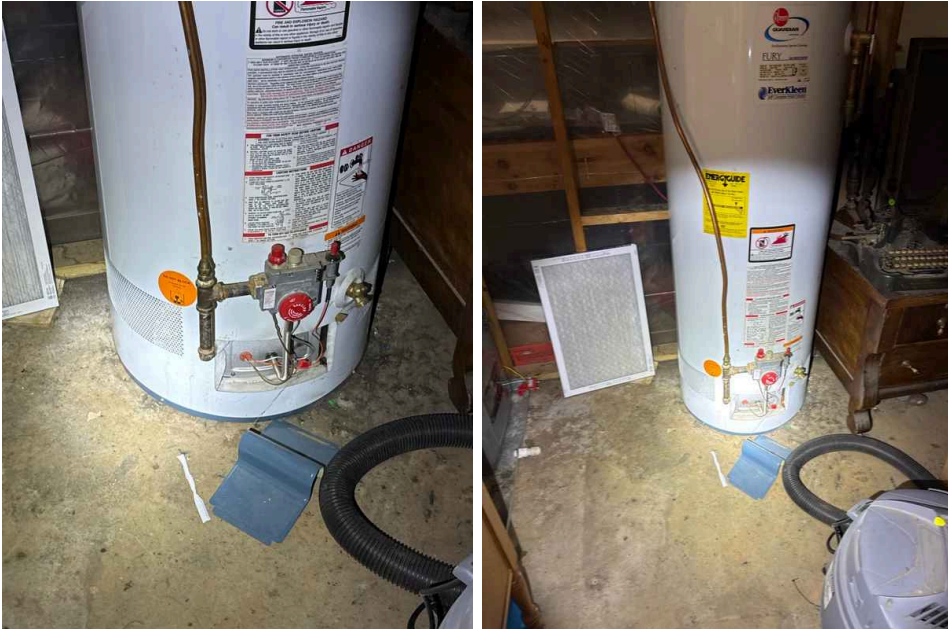
#### 9.5.2 Hot Water Systems, Controls, Flues & Vents

##### **WATER HEATER - CONCRETE**

The water heater's metal casing is in direct contact with the concrete surface. This installation practice can lead to premature corrosion of the water heater's casing over time due to moisture wicking from the concrete.

Recommend a qualified plumbing contractor evaluate and, if necessary, install a protective barrier or elevate the water heater to reduce potential for corrosion and extend the service life of the unit.

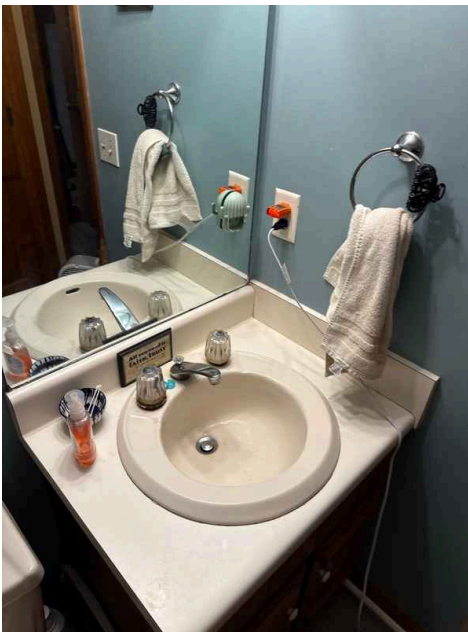
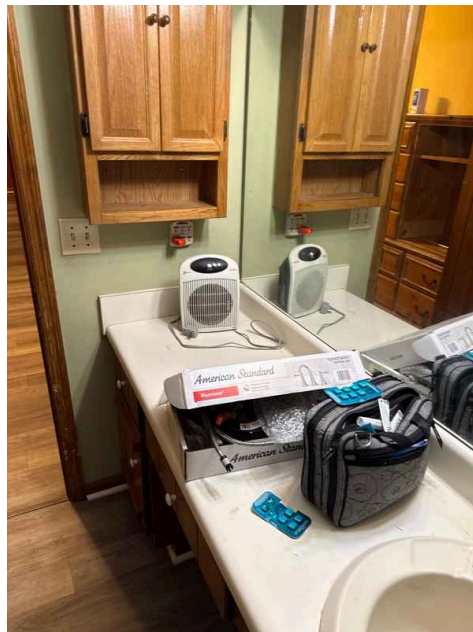
No GFCI protection present/functional. Recommend licensed electrician update by installing ground fault receptacles in all locations where within 5 feet of a water supply.

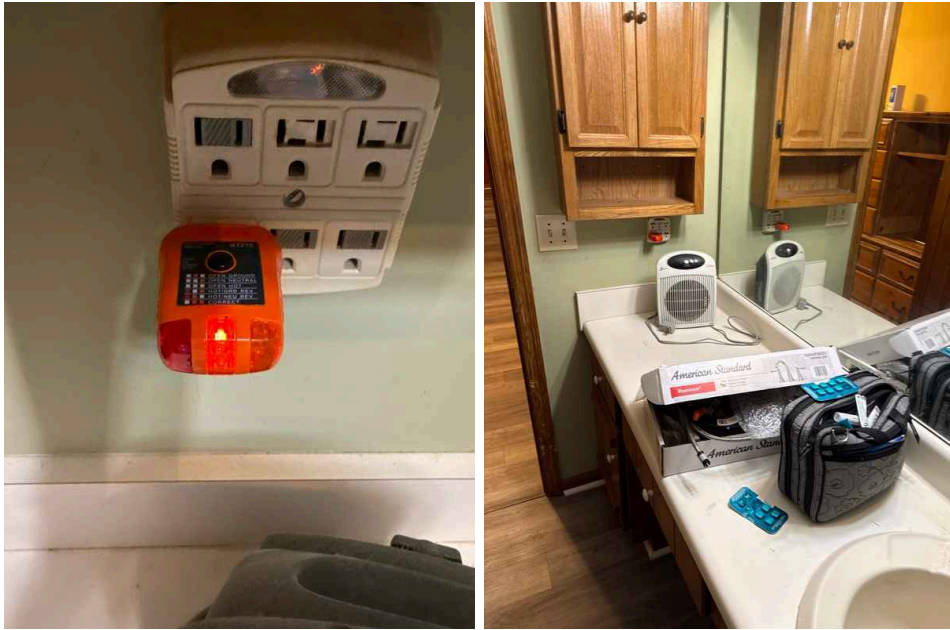
## 10.5.2 GFCI &amp; AFCI

**UNGROUNDING OUTLETS**

Observed multiple conditions of ungrounded outlets in close proximity at structure at time of inspection. Recommend further consultation with a qualified, licensed contractor to diagnose and suggest repairs as needed for proper function.

Contact a qualified electrical contractor.

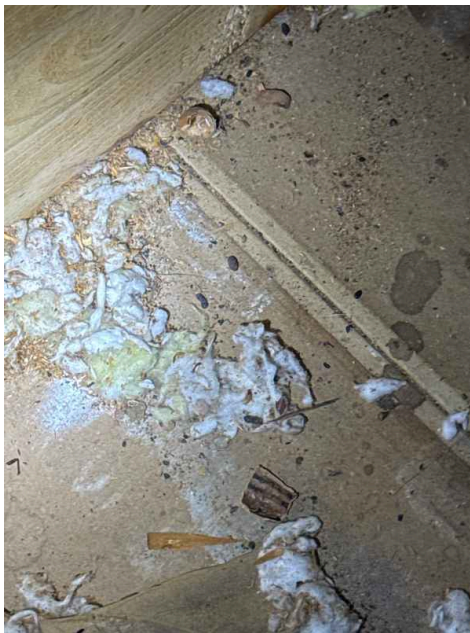
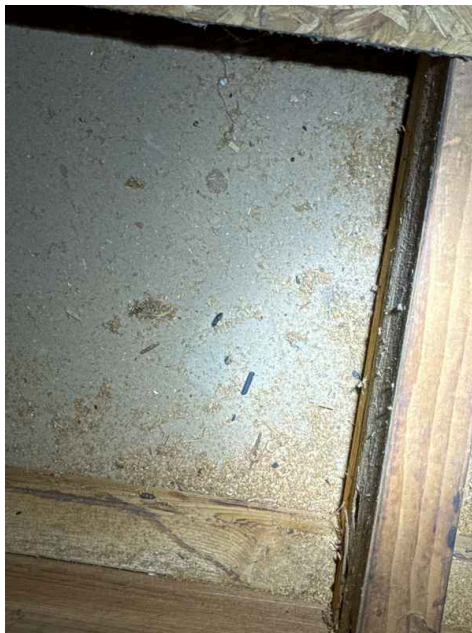
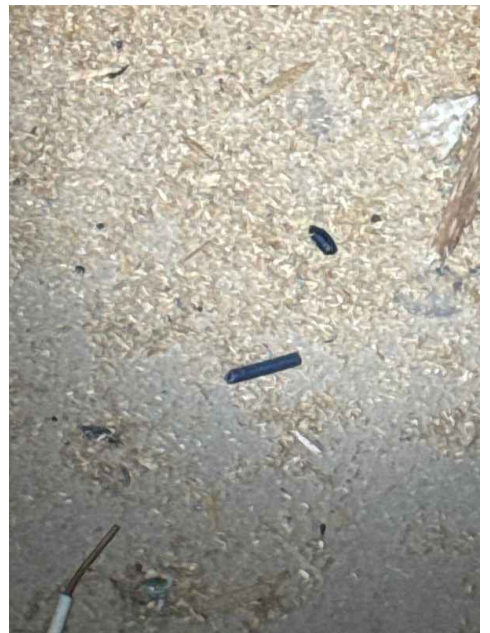
Observed evidence of rodent presence at attic. Conditions of tunneling through insulation and/or droppings observed in attic at time of inspection.

Recommend consultation with a qualified, licensed professional to remove and exclude from attic interiors.

Contact a qualified professional.

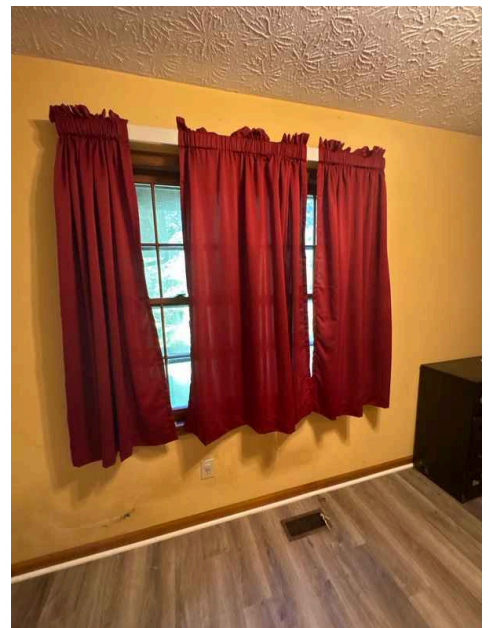
Unable to operate some windows at structure due to bolts installed at window sashes.

Recommend further evaluation and areas are accessible and functional.

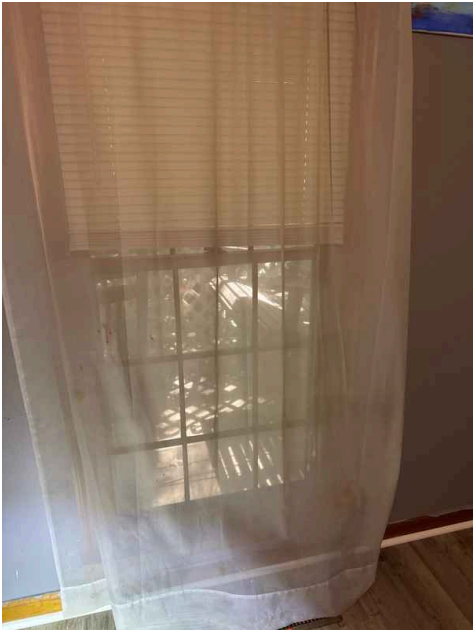
SEALED WINDOWS 2

Unable to operate some windows at structure due to bolts installed at window sashes.

Recommend further evaluation and areas are accessible and functional.

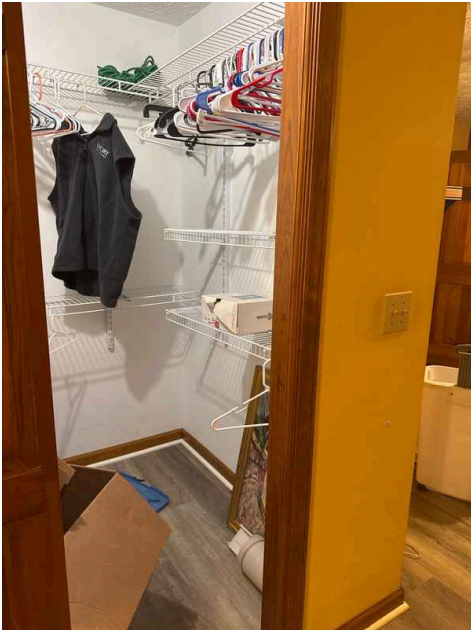
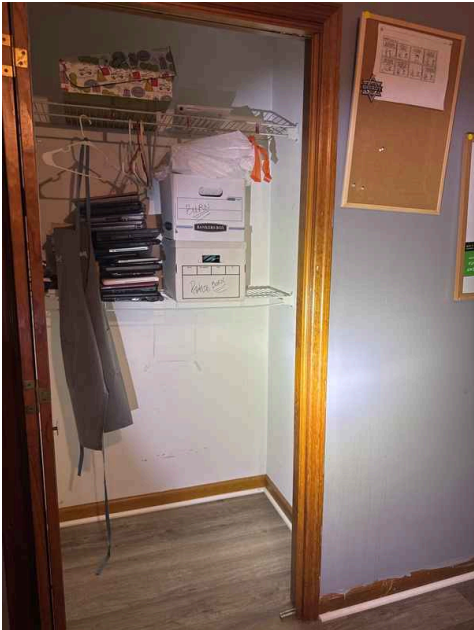
12.1.1 Doors

INTERIOR DOOR - MISSING

Door missing at time of inspection.

Recommend repair or replace as needed by a qualified, licensed professional.

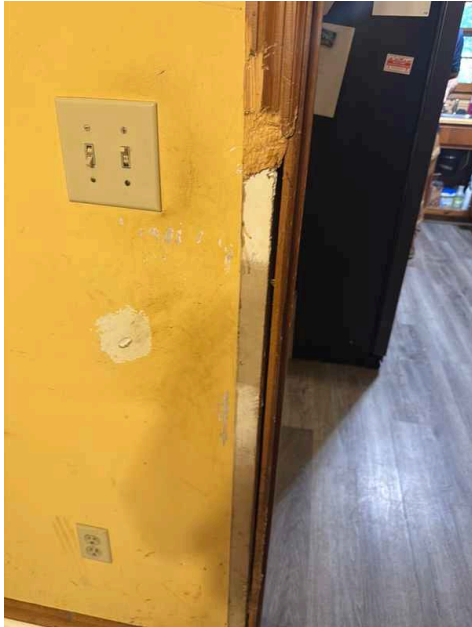
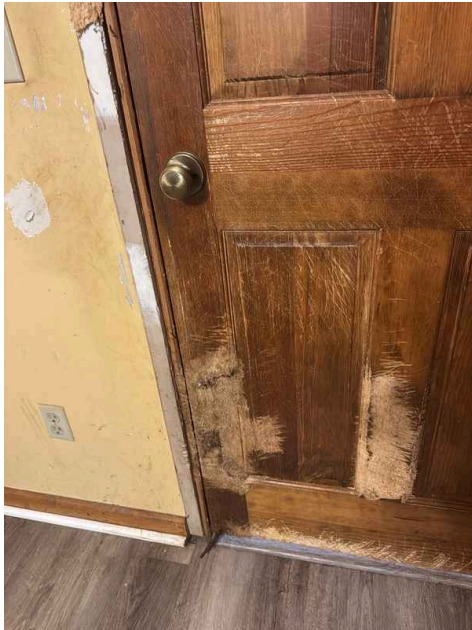
## 12.1.2 Doors

**DOOR / FRAME - DAMAGE**

Observed damage to interior door/frame at time of inspection.

Recommend repair or replace as needed.

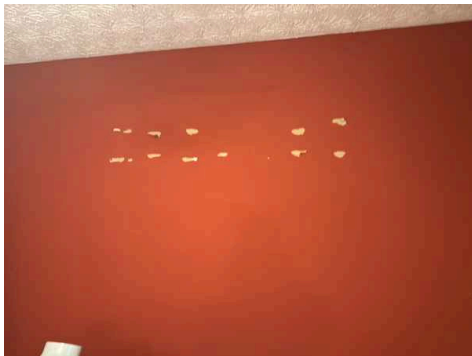
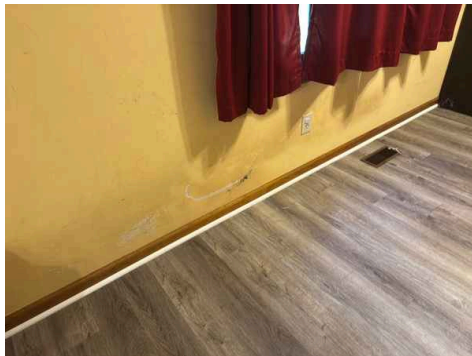
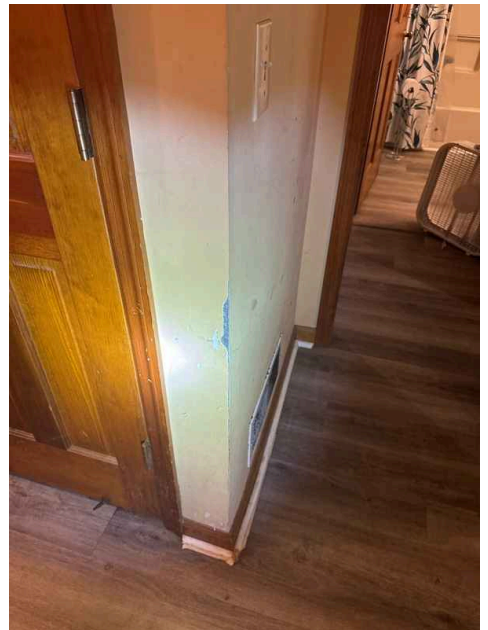
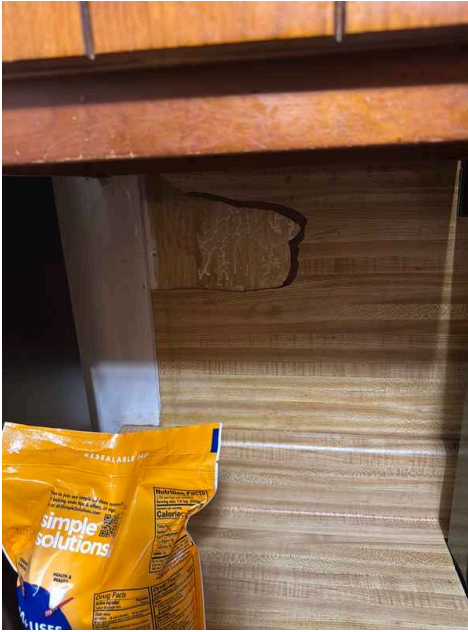
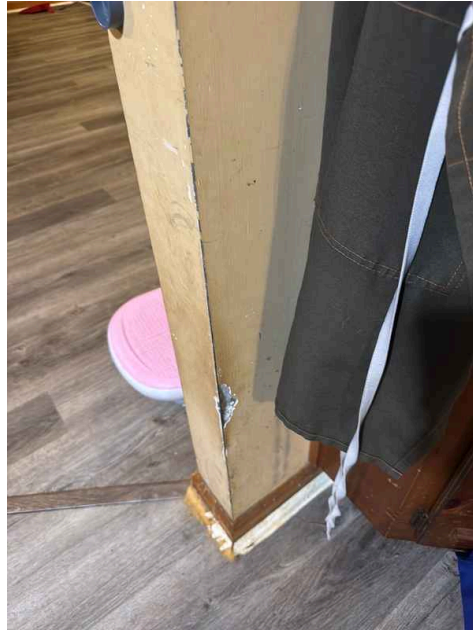
**WALL - DAMAGE**

Observed wall damage at time of inspection.

Recommend repair or replace damage finished wall materials as needed by a qualified licensed contractor.

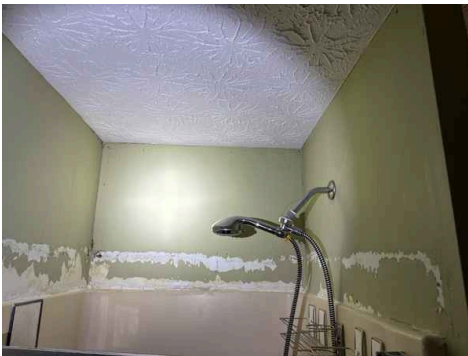
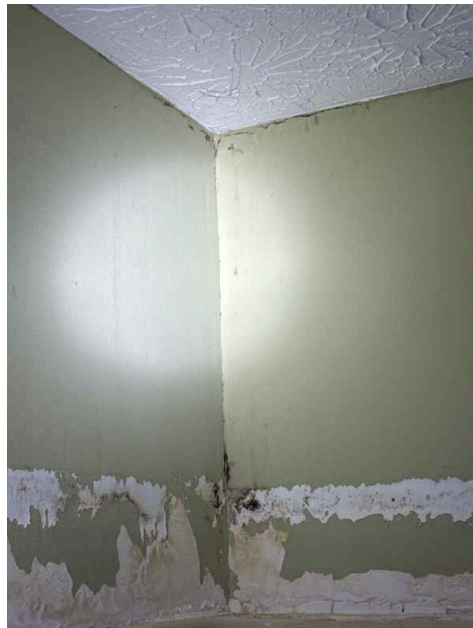
#### 12.4.2 Walls

### POTENTIAL MICROBIAL GROWTH

There are possible signs of microbial growth on wall materials. Unable to determine age or original cause for Conditions at time of inspection.

Conditions observed in multiple locations at interiors.

Recommend additional surface and/or air quality testing as needed by a qualified, licensed professional.

If positive for mold growth, remediation by a qualified, licensed mold remediation professional is recommended.

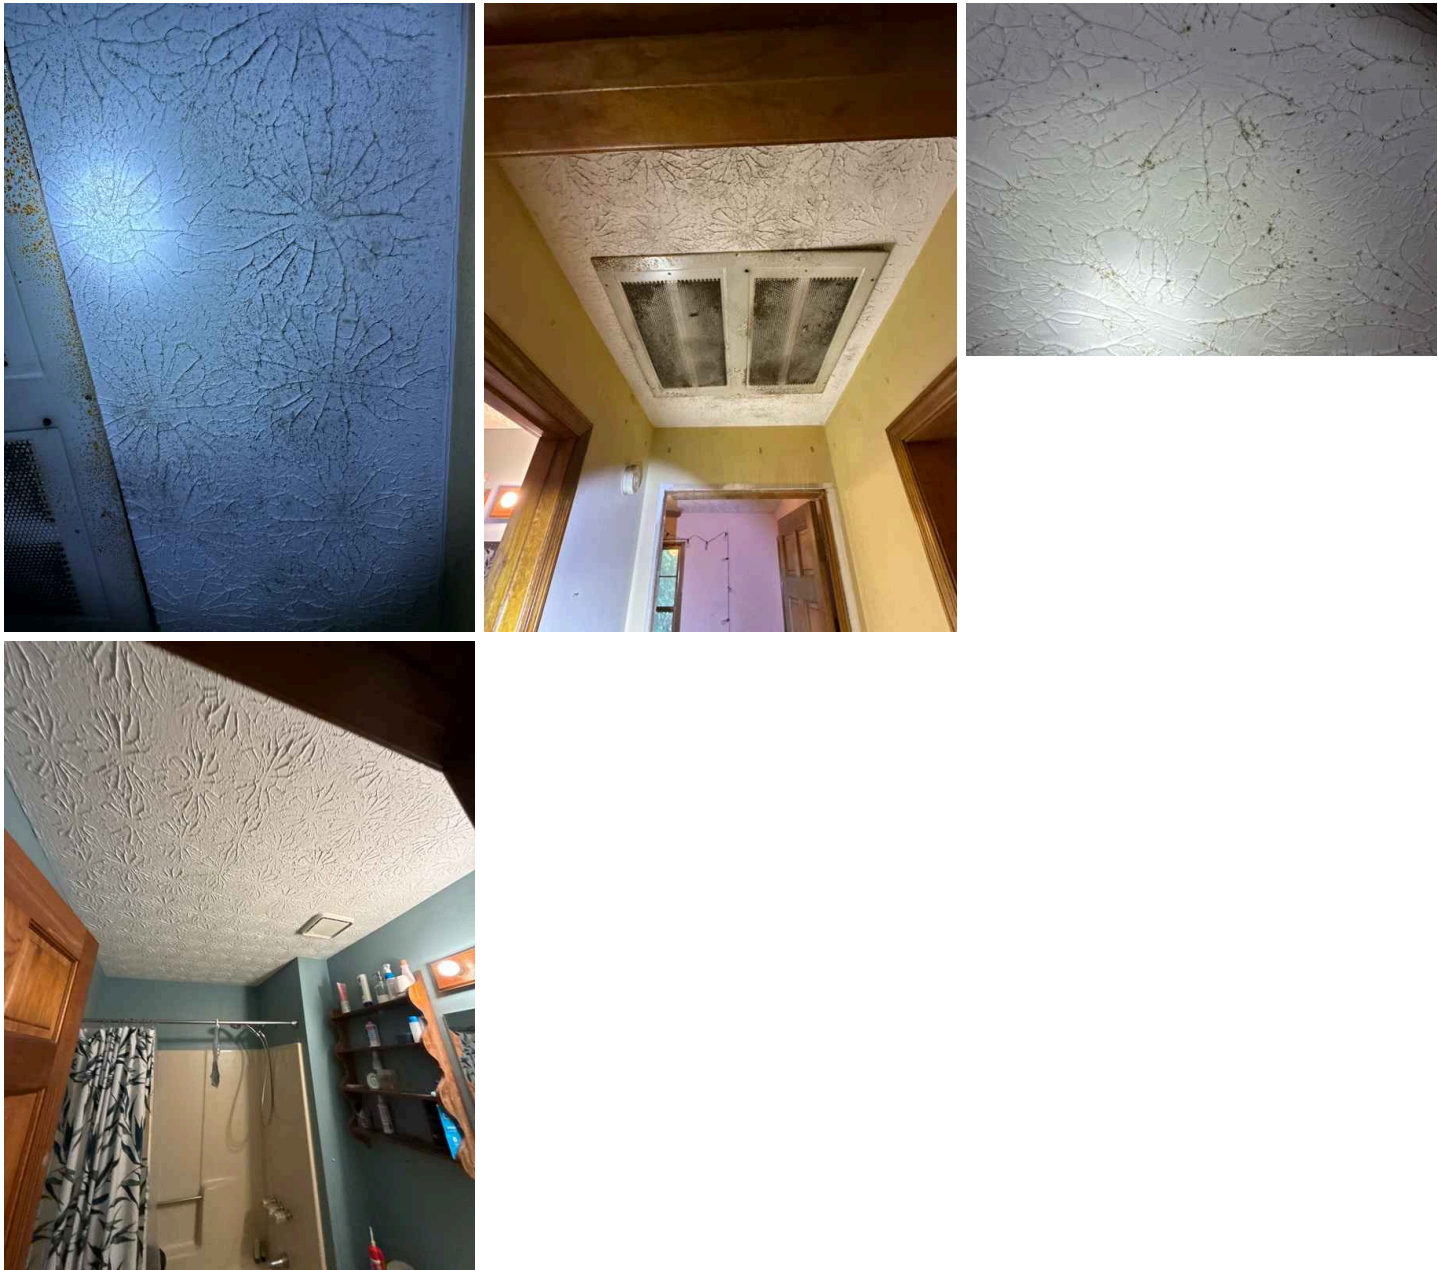
There are possible signs of microbial growth on ceiling. It is unknown if this is a safety hazard and additional testing may be warranted to help understand the more full scope of damage and/or exposure.

Recommend a qualified mold inspector evaluate. If positive for mold growth, remediation by a qualified, licensed mold remediation professional is recommended.

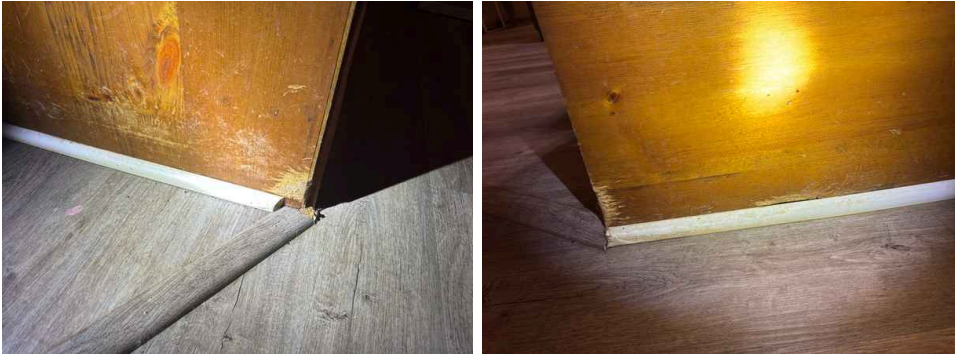
12.7.1 Countertops & Cabinets

**CABINET - DAMAGE**

Recommend repair or replace damage to cabinets as needed by a qualified, licensed professional.

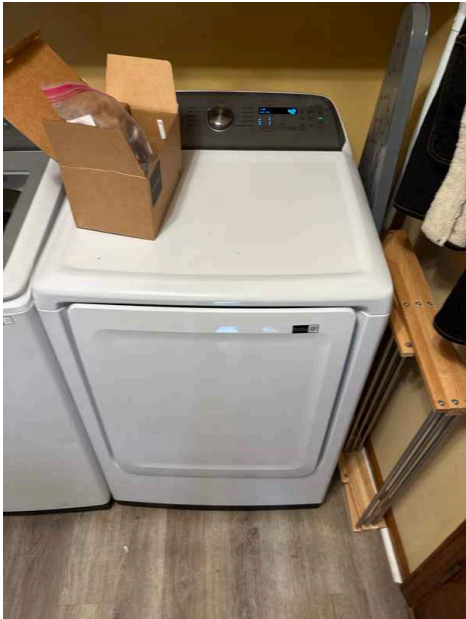
Washer/Dryer: Dryer Functional

Dryer observed functional at time of inspection.

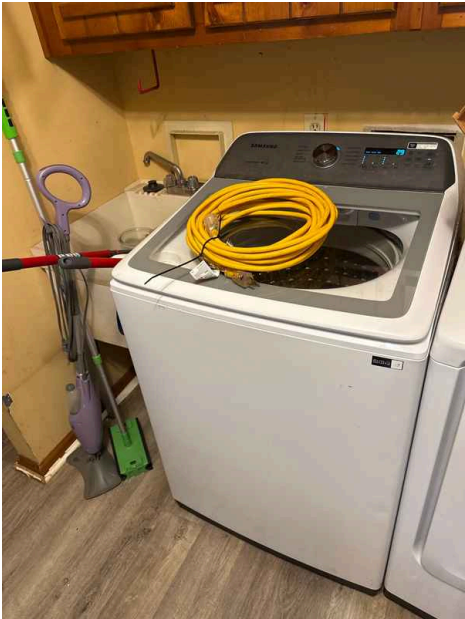
Washer/Dryer: Washer  
Functional

Washer observed functional at time of inspection.
